# The Great Eastern Japan Earthquake and Tsunami

## Facts and implications for flood risk management

Edited by  
Vana Tsimopoulou

September 3, 2012

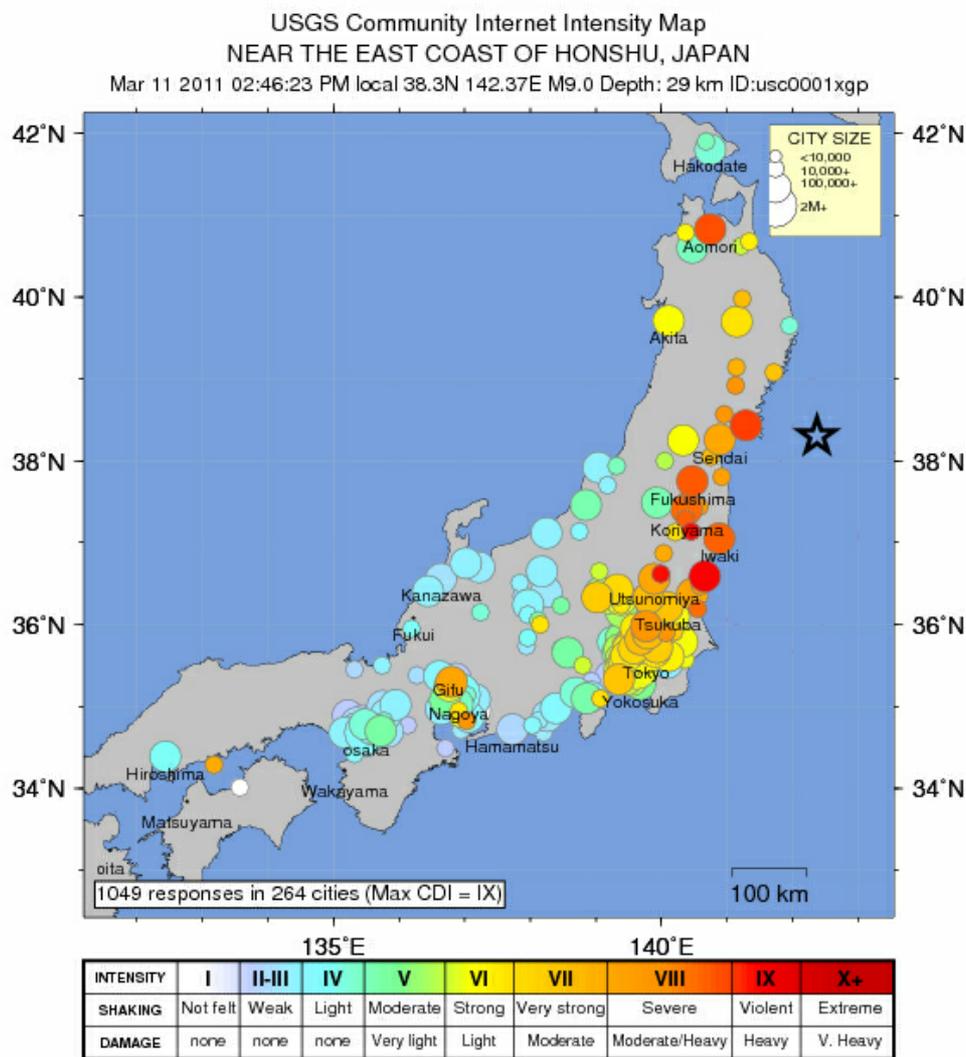
Figure 2.1: Map of earthquake intensity (USGS, 2011; <http://earthquake.usgs.gov/>)

On March 11, 2011 at 14:46 local time, a large earthquake occurred 130 km offshore the north-eastern coast of Japan. According to estimates, this earthquake was of magnitude 9.0 on the Richter scale, which makes it the largest earthquake ever recorded in Japan. The rupture area was 400 km long from north to south and 200 km from east to west. The same day a large amount of strong aftershocks of up to magnitude 7.4 on the Richter scale were recorded in Iwate, Miyagi, Fukushima and Ibaraki prefectures (figure 2.1).

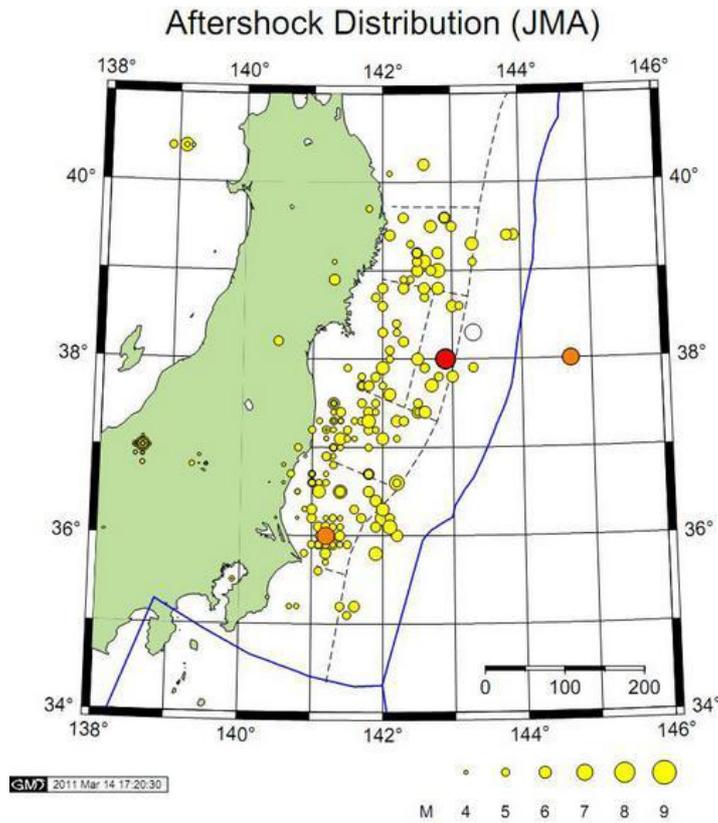
Figure 2.2: Aftershock distribution (Japan Meteorological Agency, 2011; <http://www.jma.go.jp>)

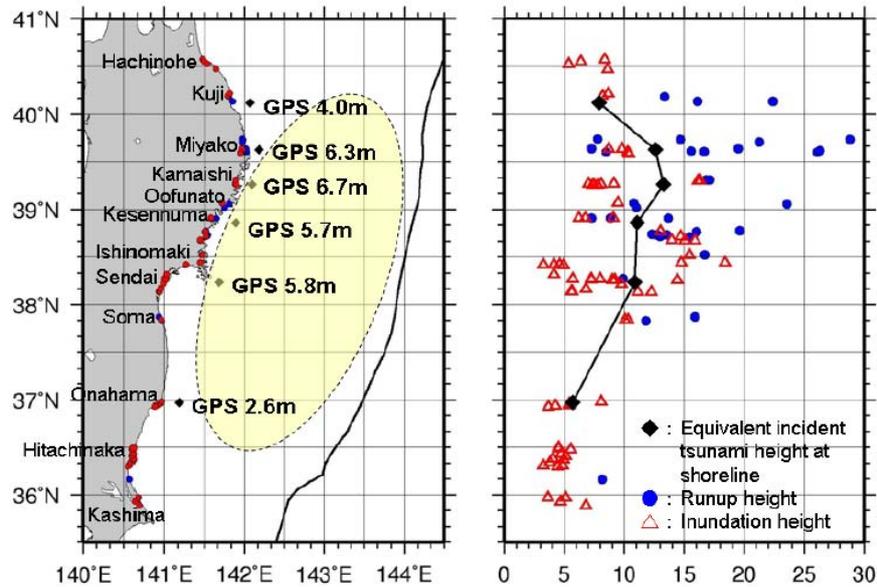
Figure 2.3: Left: Source region and GPS offshore wave records; Right: Estimated incident tsunami and measured tsunami watermarks (Takahashi et al. 2011, Courtesy of Port and Airport Research Institute, *all rights reserved*)

Three minutes after the main earthquake, the Japan Meteorological Agency issued a tsunami warning, and soon after that the GPS mounted buoys at a spot of 100-200 m in water depth off the Tohoku coast recorded a 2.6 to 7.7 m high tsunami (Kawai et al. 2012). Due to shoaling, a deep-water wave of this magnitude is expected to exceed 10 m in height when reaching coastal waters, while its exact value is very much dependent on the local bathymetry and morphology of the coast. A few minutes later those huge waves were indeed reaching the north-eastern Japanese coast, starting from Miyagi, Iwate and Fukushima prefectures, and expanding gradually to the entire north-eastern Japanese coast from Hokkaido in the north to Chiba in the south, affecting approximately 1300 km of the coastline. The rupture area where the tsunami was generated and the coastal tsunami characteristics in Iwate, Miyagi and Fukushima, as reported by Takahashi et al. (2011), are shown in figure 2.3.

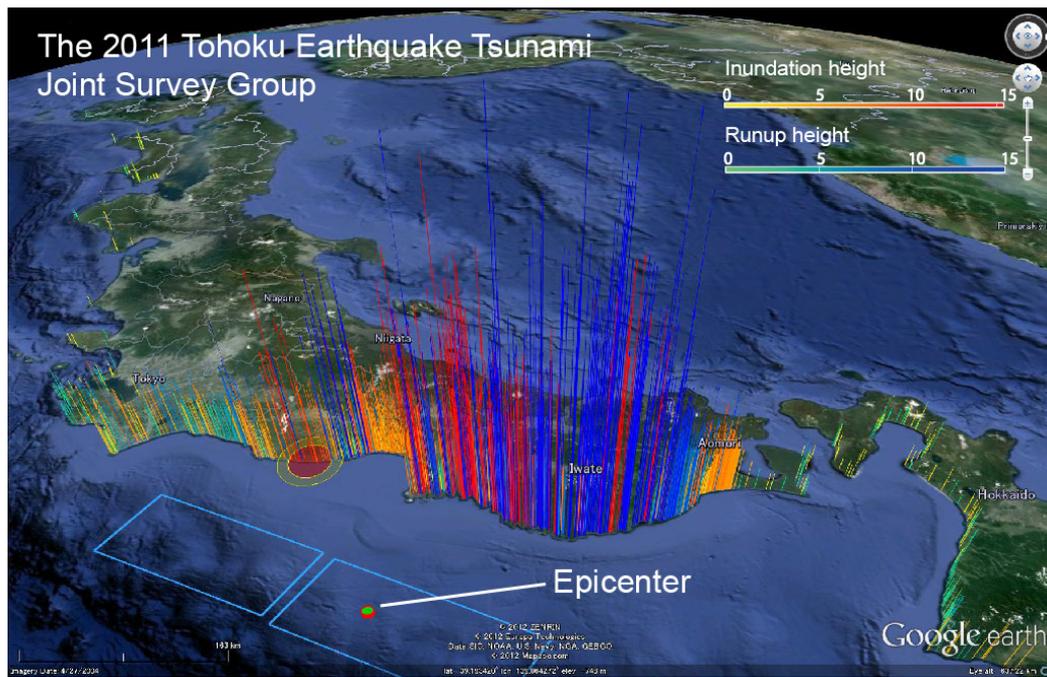
Figure 2.4: Overview of the tsunami survey results (Source: The 2011 Tohoku Earthquake Tsunami Joint Survey Group; [www.coastal.jp/tsunami2011](http://www.coastal.jp/tsunami2011))

Following the disaster, the Japanese scientific society took immediate action by organizing the 2011 Tohoku Earthquake Tsunami Joint Survey Group (Mori et al. 2012). The purpose of the group was to survey the tsunami inundation and run-up along the affected coast. This is the largest ever-assembled tsunami survey group consisting of academics, engineers and governmental officials. More than 300 members of the coastal engineering committee of Japan participated in the surveying effort, while there was support of local authorities and governmental agencies (Mori et al. 2012). Most of the collected data are accessible on the website of the Japanese Coastal Engineering Committee, while there are already some publications about the surveys in scientific journals, such as the special issue of Coastal Engineering Journal. An overview of the results of all surveys along the Japanese coast is shown in figure 2.4.

Inundation was induced all along the Eastern coast of Japan, while the highest inundation and run-up heights were encountered along the coast of Tohoku. In particular, the height of inundation exceeded 20m in about 200Km of coastline, while along 530 km the height of inundation was over 10m. The maximum-recorded run-up height is 40 m, which exceeds the historical highest run-up record of 38.2 m, during the Meiji tsunami of 1886 (Mori et al. 2012).

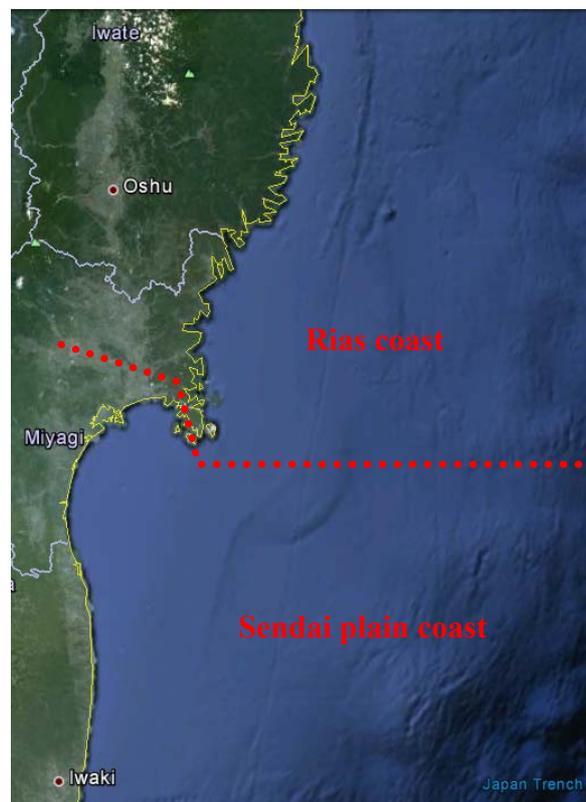
Figure 3.2: Coast types in Tohoku

In order to comprehend the tsunami behaviour and disaster patterns in the coastal areas presented in this chapter, it is important first to consider what does the coastal morphology of Tohoku look like. Some significant morphological variations can be noted along the coastline of Tohoku that are responsible for variations in the local tsunami behaviour. The stricken coastal zone can be classified in two categories: 1) the rias coast in the northern half of Tohoku, and 2) the coastal plain in the southern half (figure 3.2). These two coastal types are described below in more detail.

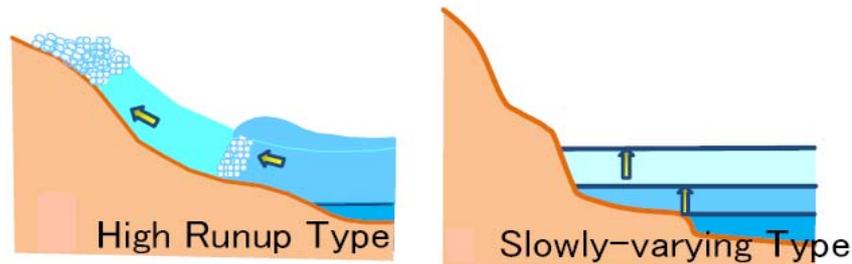
The rias coasts are therefore extremely irregular and indented in places, forming narrow and steep bays. At this type of coast, due to bathymetry focusing effects, the tsunami height increases. The narrow bays are surrounded by high grounds that face the ocean with steep cliffs, and relatively deep sea in the front. The basin created by the high grounds obstructs the intrusion of seawater far inland, which, combined with the increased tsunami height, resulted in large inundation and run-up heights (figure 3.3).

Figure 3.3: Typical cross sections of tsunami intrusion at rias coast (Source: Takahashi et al. 2011; Courtesy of Port and Airport Research Institute, all rights reserved)

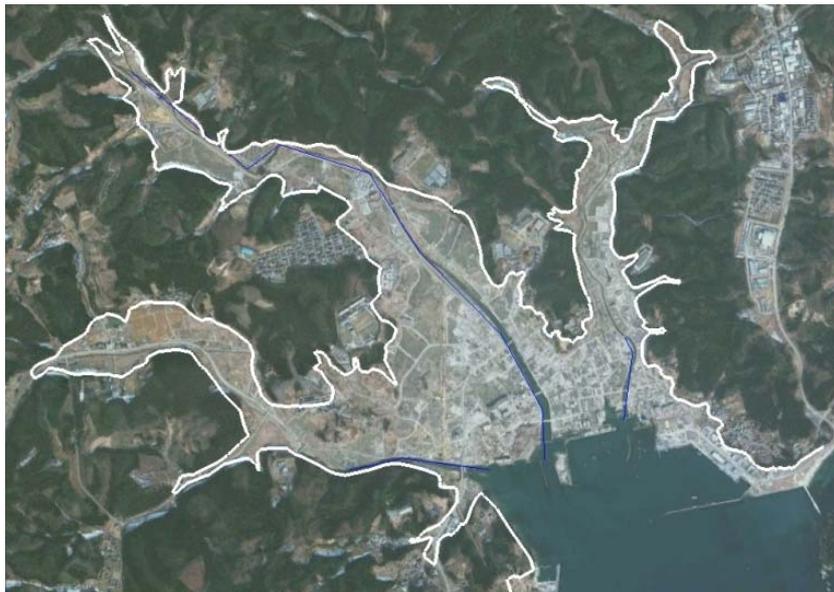
Figure 3.4: Inundation pattern in the rias. The white line is the boarder of the flooded area.

Most urban and industrial areas in the rias are built in the basins that surround the narrow bays; hence the majority of coastal defences in this part are concentrated in the bays. The inundation pattern in Minamisanriku, a typical town in the rias, is shown below.

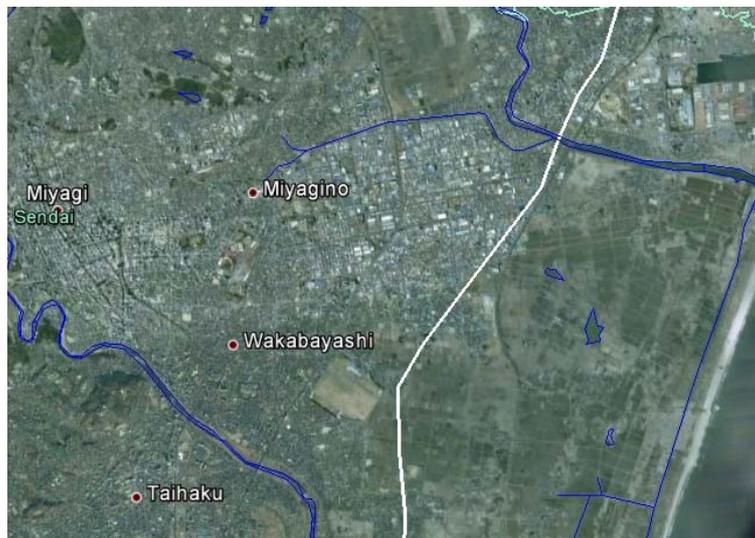
Figure 3.6: Inundation pattern in the coastal plain. The inundated part extends on the right side of the white line.

The tsunami intrusion at this type of coast is shown in the following graph. Because of the sea dykes and dunes, fewer breakwaters can be found on the coast of these flat plain areas. Nevertheless, a number of ports are located throughout this coastline, and these were indeed protected by a variety of breakwater types. The inundation pattern in the frontage of Sendai city is shown in figure 3.6.

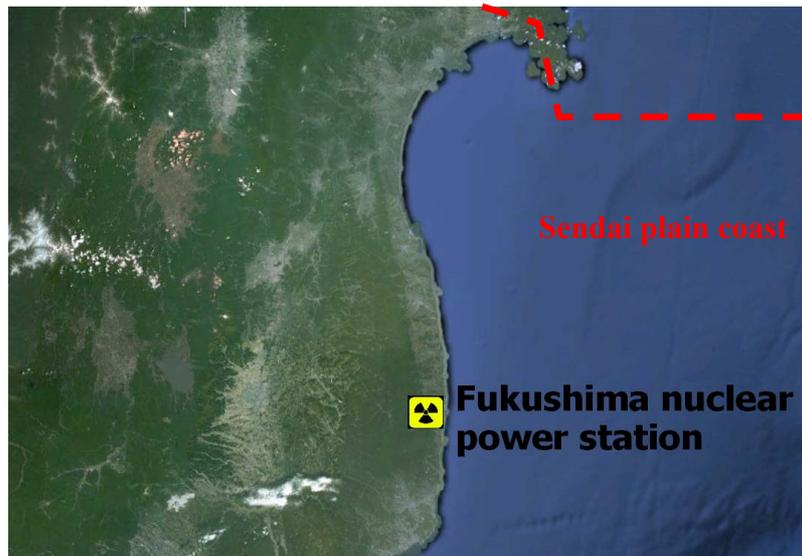
Figure 3.7: Position of Fukushima Daiichi nuclear power plant

Fukushima Daiichi nuclear power station, where the major nuclear catastrophe took place due to the tsunami inundation, lies also in this part of the coast (figure 3.5). According to some information reported in the Wall Street Journal in July 2011 though, the original ground elevation at the site where the power station was placed was about 30 m, forming a natural sea defence. During the construction of the power station in 1967 the ground elevation was reduced to 10 m, so as to make it easier to pump seawater to the reactors. Apparently the expected tsunami inundation taken into account in the design of the station was much lower than the tsunami of March 2011.

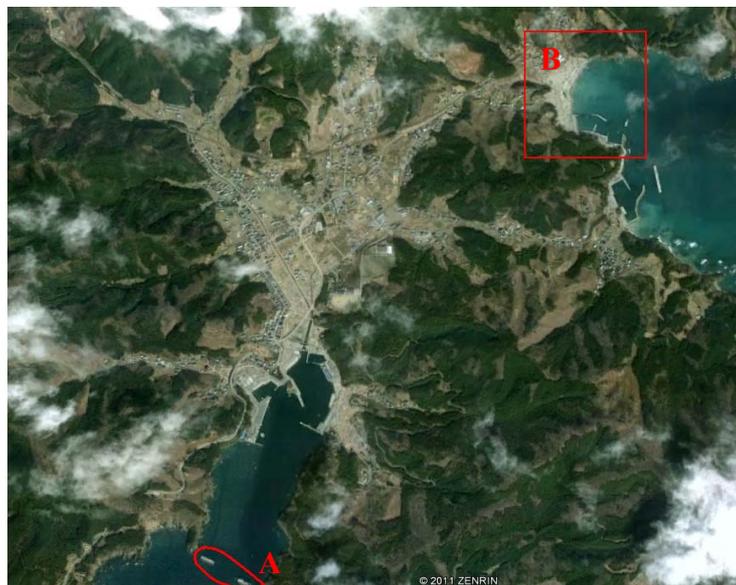
Ryori is a village in a small bay in the rias, protected by a caisson breakwater. To the east of the town there is another small bay with a sandy beach and a harbour. At this small bay the run-up height reached 40 m, which is the highest recorded run-up of this tsunami, but also the highest ever recorded tsunami run-up height in Japan (Mori et al. 2012). There was a tsunami protection wall in that small bay that was overtopped and seriously damaged, with a big section removed at its northern end.

Figure 3.8: Ryori bay after the tsunami. The severely damaged caisson breakwater (A) and the sandy beach with the tsunami wall (B) are designated (Google earth caption, 2011)

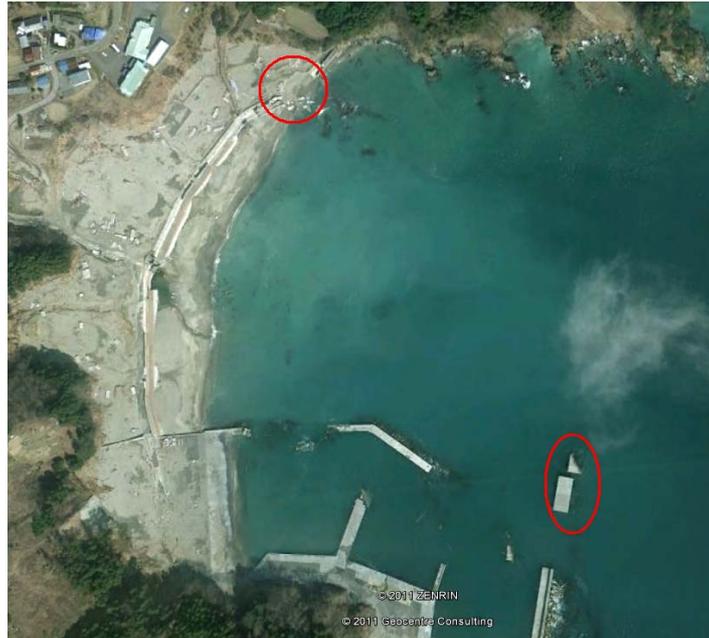
*Figure 3.9: Zoom in the bay where the visited tsunami wall is located (region B). A large section of the tsunami protection dyke was broken at its north end, and severe damage of the caisson breakwater was also noted (Google Earth caption, 2011)*

The tsunami gates that were originally attached on the wall were displaced towards the seaside. This shows that the cause of their failure was probably the run-down of the tsunami. As the land slope is quite steep in that area, a strong run-down must have been induced. On the backside of the wall there were large accumulations of debris and stones, which also provide evidence of a strong run-down. During the time of the survey work was carried out to temporary strengthen the structure with placement of sandbags. The caisson breakwater located in the small harbour was also seriously damaged.

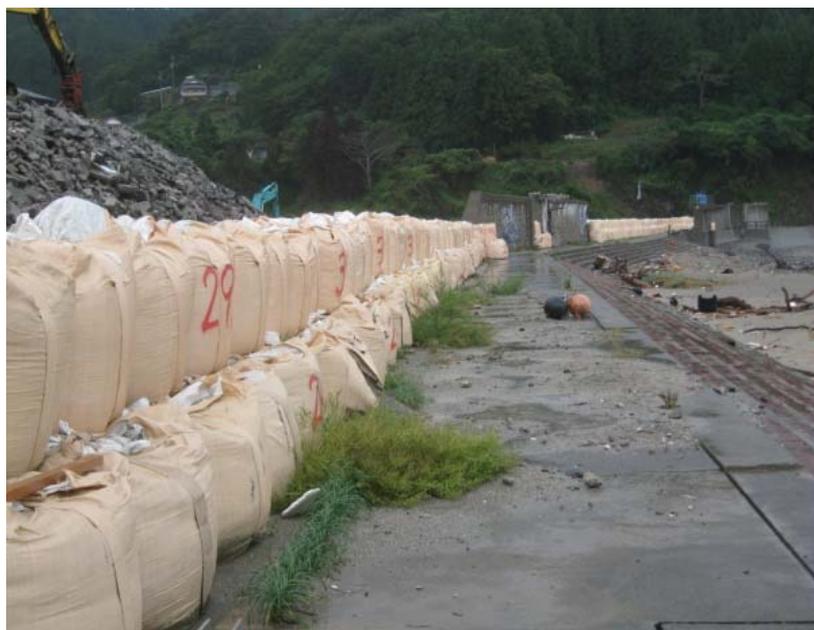
*Figure 3.10: Temporary protection measures against storm surges.*

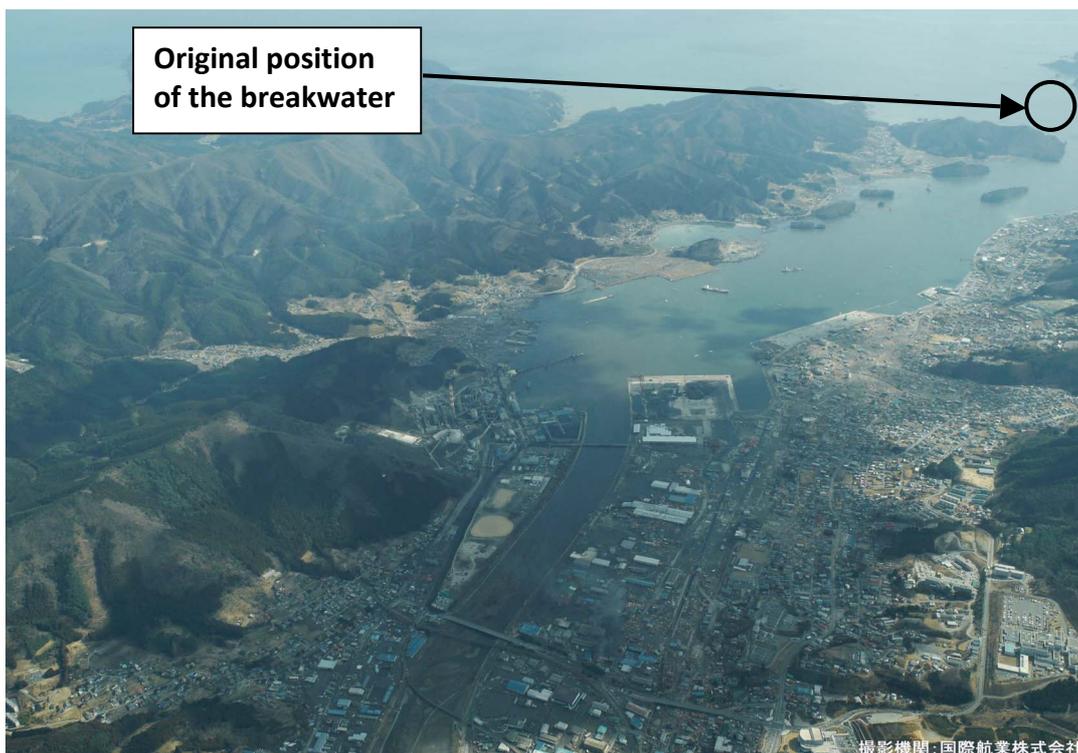
The bay of Ofunato used to be protected by an offshore tsunami breakwater, which after the tsunami of March 11 had completely disappeared under the water. This breakwater was designed to withstand the attack of the Chilean tsunami of 1960, triggered by an earthquake of 9.5 magnitude on the Richter scale, that caused severe damages all around the Pacific Rim, including Sanriku region, where also a loss of over 100 lives was recorded. It is still not clear what was the mechanism that caused this catastrophic structural failure during the tsunami of March 2011.

Figure 3.11: Ofunato bay on March 12, 2011. The position of the completely destroyed tsunami breakwater is designated on the upper right corner. (Source: [www.kk-grp.jp](http://www.kk-grp.jp); Courtesy of Kokusai Kogyo Holdings Co. Ltd, *all rights reserved*)

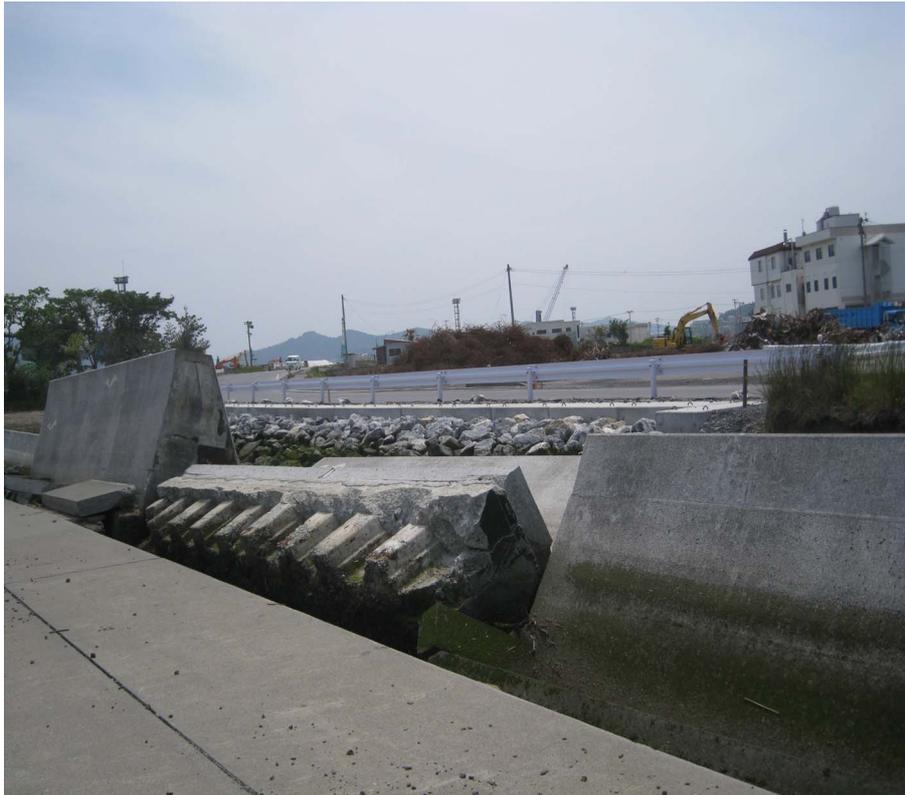
Apart from the breakwater, a concrete sea wall could be found along the southern waterfront, which also failed. More than 1 m deep scouring could be observed on the outer side of the wall, while many parts of it were overturned (figure 3.13).

*Figure 3.12: Failed sea wall of Ofunato photographed in June 2012.*

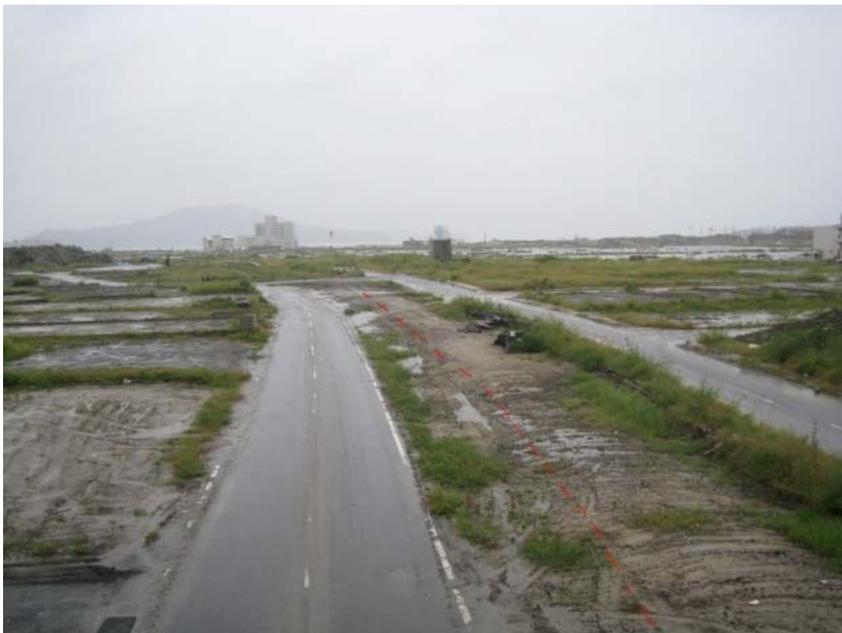
*Figure 3.15: Empty space that used to be a railway reaching a station. Both the railway and the station were devastated.*

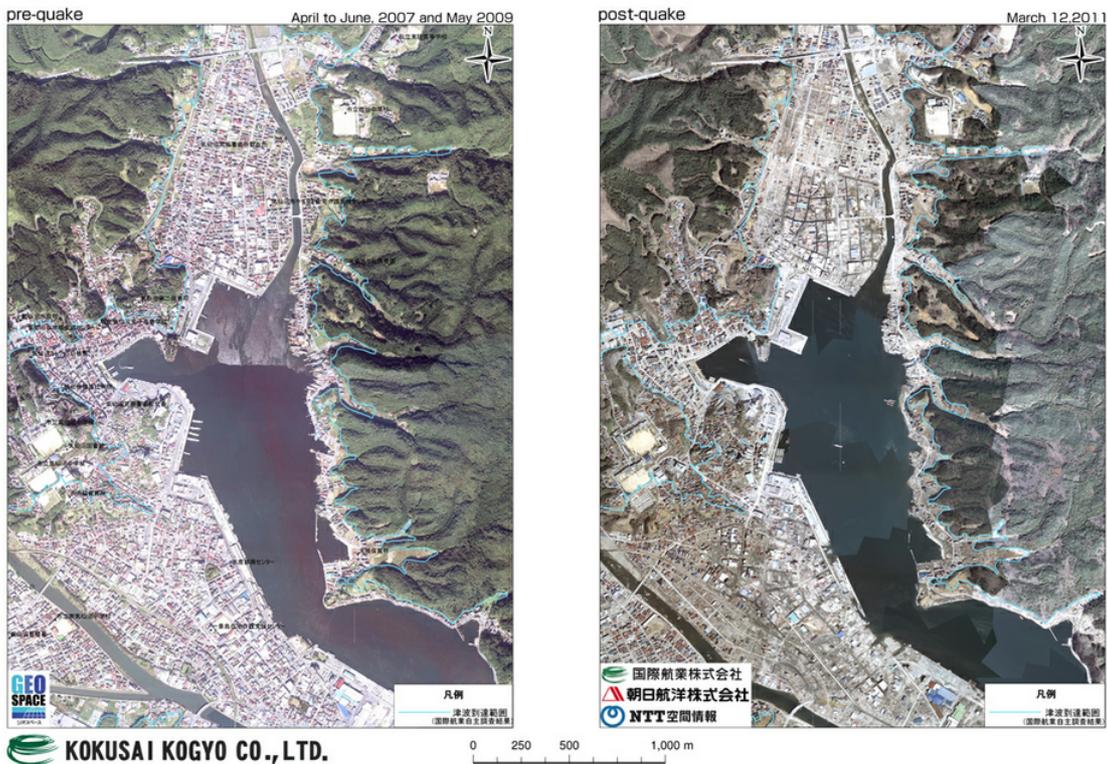
Figure 3.16: Kesenuma before and after the tsunami (Source: [www.kk-grp.jp](http://www.kk-grp.jp); Courtesy of Kokusai Kogyo Holdings Co. Ltd, all rights reserved)

Kesenuma lays 12 km to the south of Rikuzentakata, and was likewise severely damaged, with an inundation reaching 15 m in many spots on the frontage. Apart from the tsunami, Kesenuma also suffered some fire damages, as heavy oil was spilled and burnt during the tsunami attack. Important subsidence could be observed at the harbour, which moved the waterline inland, towards the first roads. Some parts of the quay walls were completely inundated, and temporary shore protection using sandbags was placed to prevent expansion of the erosion further inland. At the time of the survey, most of the rubble had already been cleaned up, yet much work was still needed.

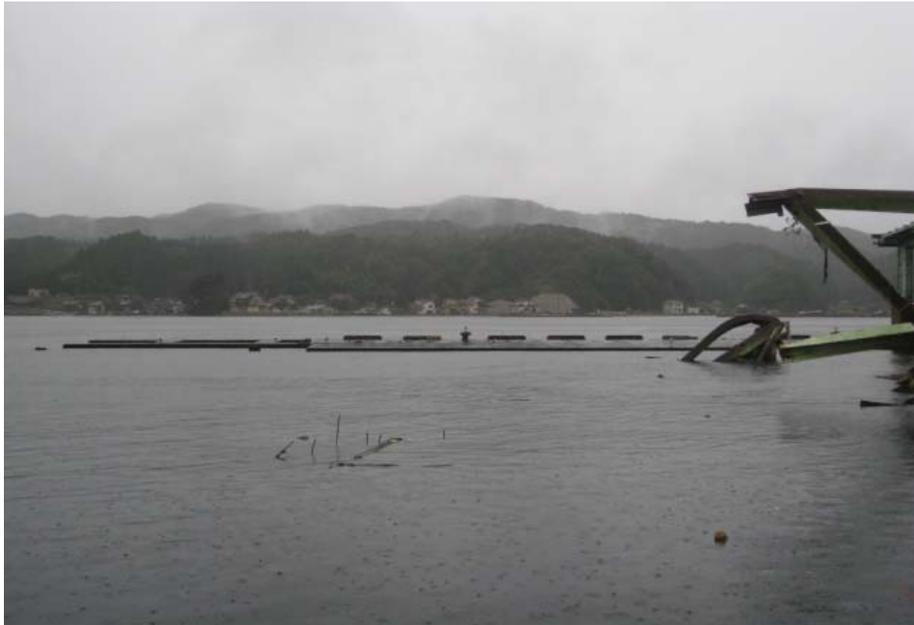
Figure 3.17: Submerged quay wall

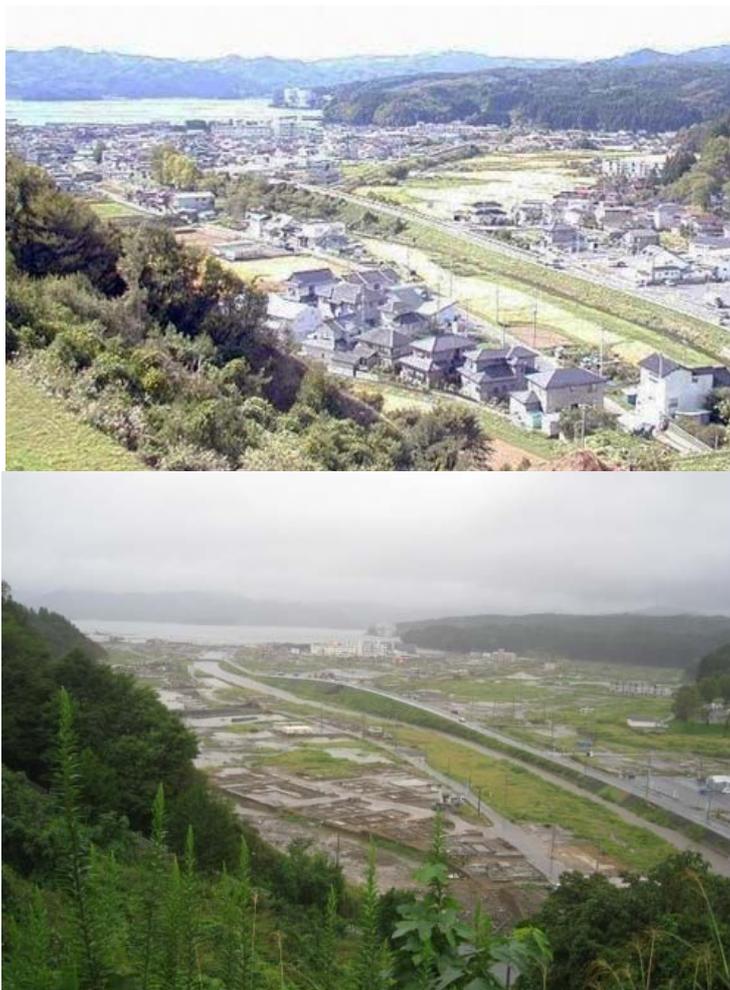
Figure 3.18: Minamisanriku before and after the tsunami (Source (top): Shizugawa Junior High School, rights unknown)

Minamisanriku is located in a quite narrow, fjord-like river valley. The town was devastated by the tsunami, with very little of it left. Like in Rikuzentakata, the tsunami ran-up along the river for a considerable distance. At this area the inundation line was clearly visible on the slopes of the mountains, where the inundated part of their forest was brown in colour, contrasting the green of the higher grounds. The inundation heights near the front of the town exceeded 15m, while the maximum run-up was in excess of 35 m.

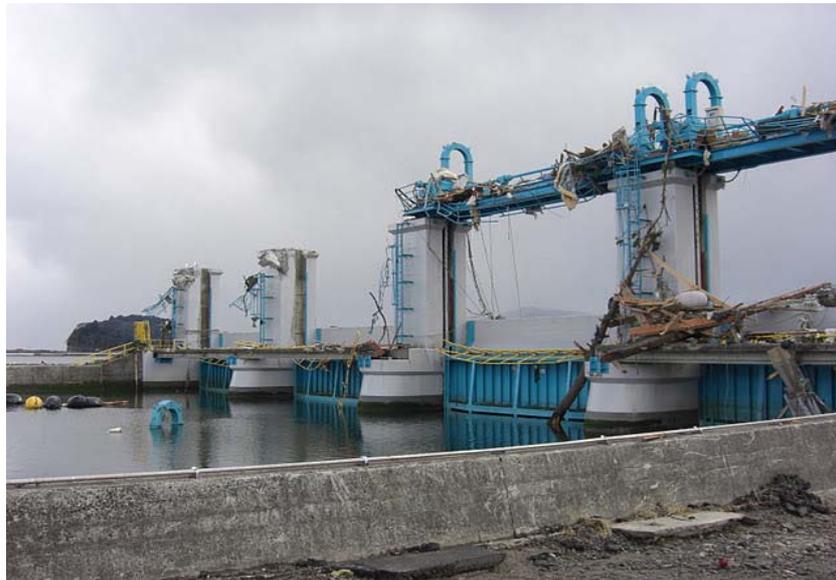
On the waterfront of Minamisanriku serious subsidence and erosion could be seen, as well as damage to coastal roads. The transportation in the area had not fully recovered at the time of the survey. The storm surge gates at the mouth of the river were also severely damaged, as well as parts of the river dikes. Some temporary protection measures have been attempted in the form of sandbags. On the northwest side of the town some temporary houses had been constructed in the sides of the hills, where the local population was being sheltered following the destruction of their houses.

Figure 3.19: Severely damaged storm-surge gates (Source: The 2011 Tohoku Earthquake Tsunami Joint Survey Group; [www.coastal.jp/tsunami2011](http://www.coastal.jp/tsunami2011))

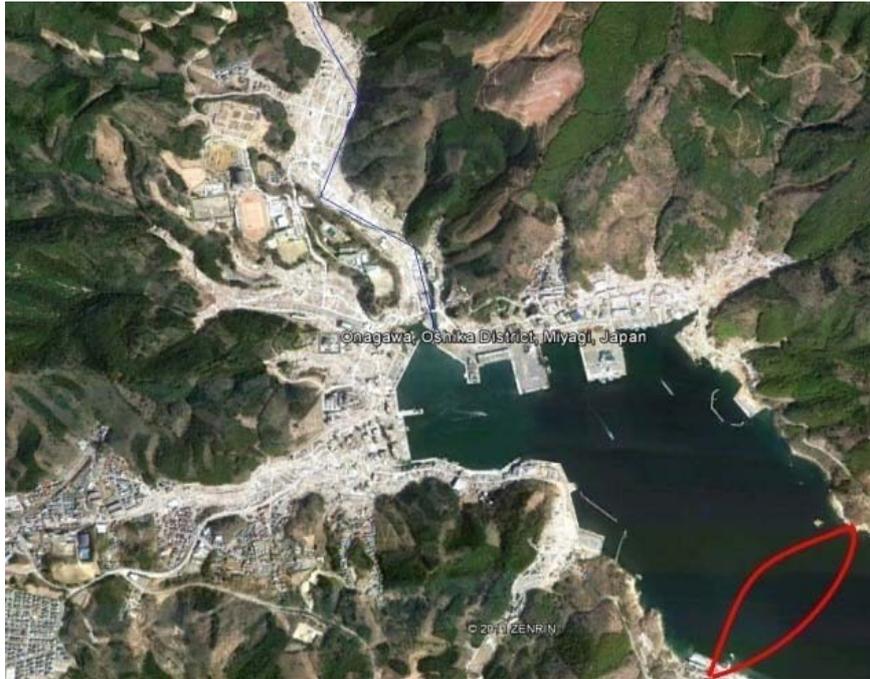
Onagawa is located further to the south of Miyagi prefecture, yet still in the rias coast, almost at the south end of it. This town received much media attention due to extensive damage that took place. The bay of Onagawa was protected only against storm waves by a caisson breakwater, which had not been designed to withstand tsunami waves, and which was completely destroyed.

Figure 3.20: View of Onagawa after the tsunami. The position of the failed breakwater is remarked. (Google Earth caption, 2011)

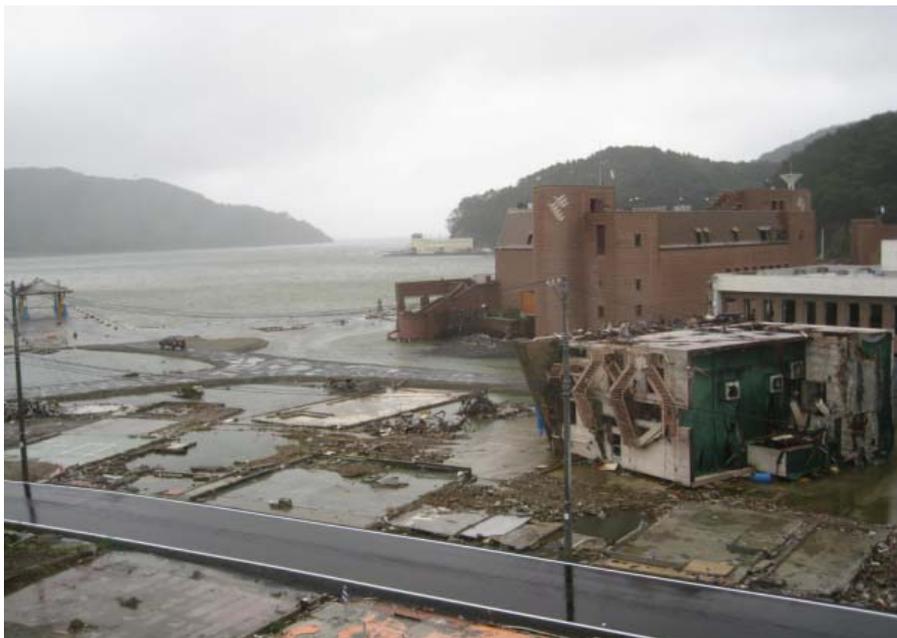
In the low-lying part of the city all wooden buildings were devastated, while it was interesting to see that many concrete buildings were overturned. The cause of this special type of failure must have been the fact that those buildings had pile foundations that due to the earthquake had failed in shear and were thus detached from the bottom of the building, and as a consequence the uplifting tsunami forces overturned the entire building. Liquefaction might have also played a role to this failure. Furthermore, some significant subsidence at the waterfront was evident, like in most areas in the rias. The inundation height near the shore was around 15 m.

Figure 3.21: Devastated waterfront of Onagawa

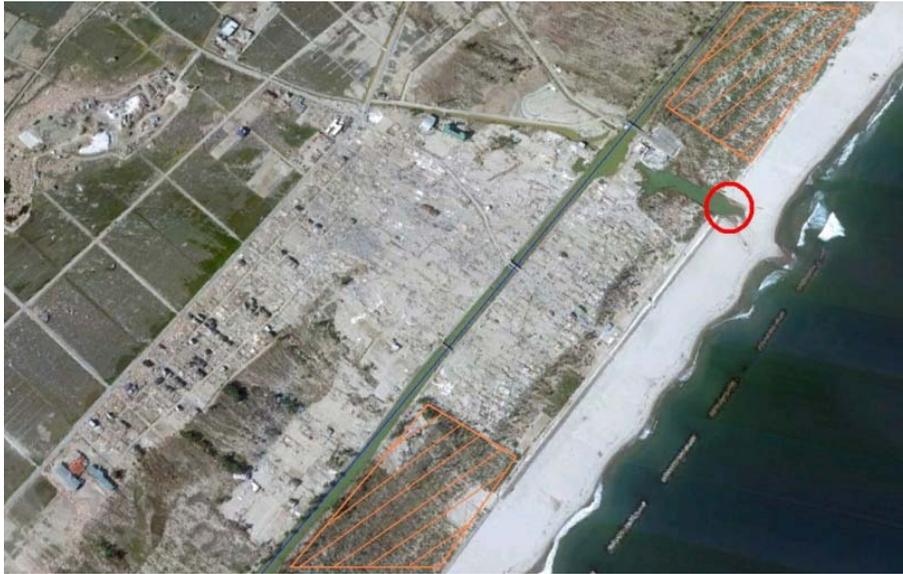
Figure 3.22: Arahama after the tsunami. The breakage on the sea dike is remarked with red, and the devastated forest zone is remarked with orange (Google earth caption, 2011)

The dike was overtopped by the tsunami of March 11 and propagated over to the flat land, inundating many square km of rice paddies, and devastating a coastal pine tree forest and the settlement of Arahama. The sea dike broke to the northeast of the settlement. The inundation depths in Arahama were relatively lower than the ones recorded in the coastal cities in the rias. The watermarks and damage to concrete buildings that survived the tsunami were up to the second floor. It is notable that some concrete buildings behind the dike that were founded on sandy subsoil did remain in place, yet significant scouring on

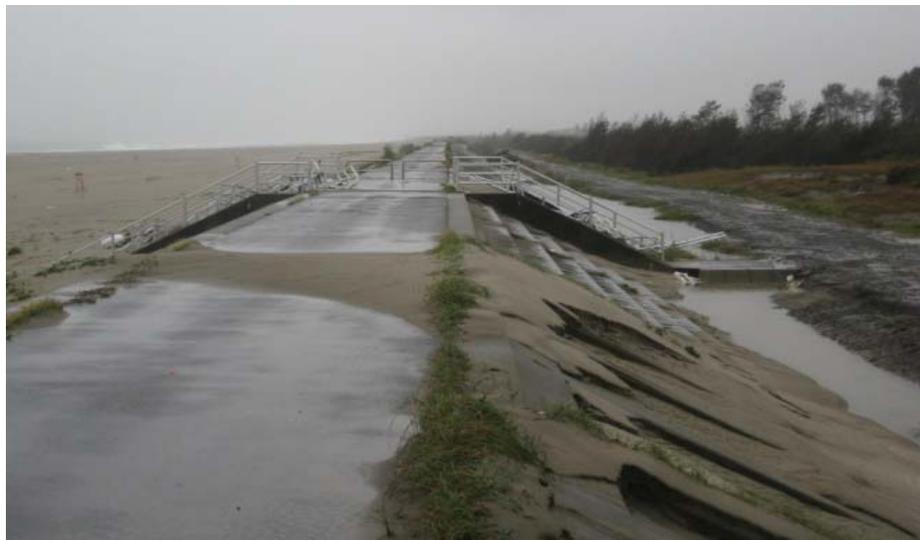
Figure 3.23: Sandy beach and sea dike at Arahama Wakabayashi-Ward

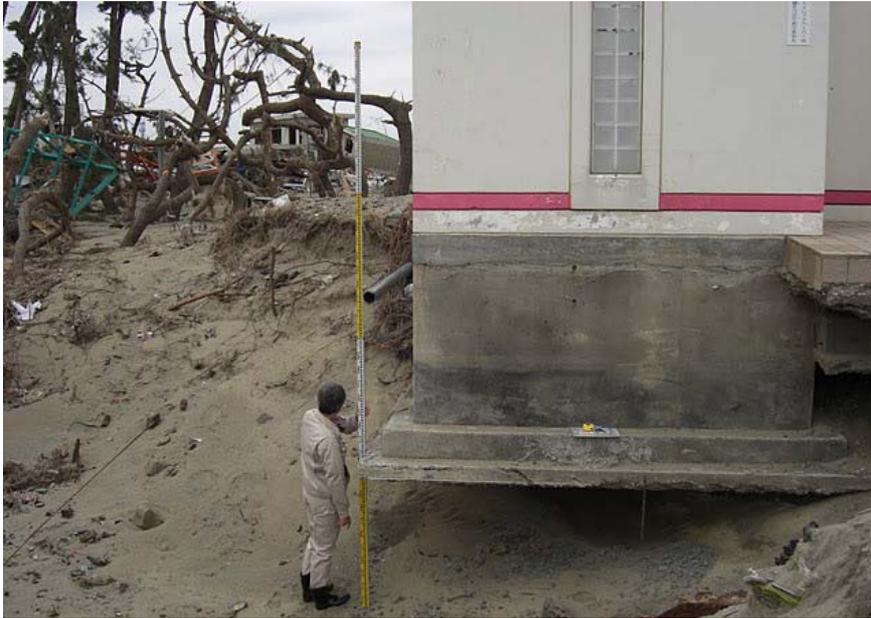
their toe was observed, which exceeded 2.5 m in places. Scouring due to overtopping tsunami waves is considered to be the main cause of failure of the sea dikes in that area.

Figure 3.24: Scouring on the toe of concrete building (Source: The 2011 Tohoku Earthquake Tsunami Joint Survey Group; [www.coastal.jp/tsunami2011](http://www.coastal.jp/tsunami2011))

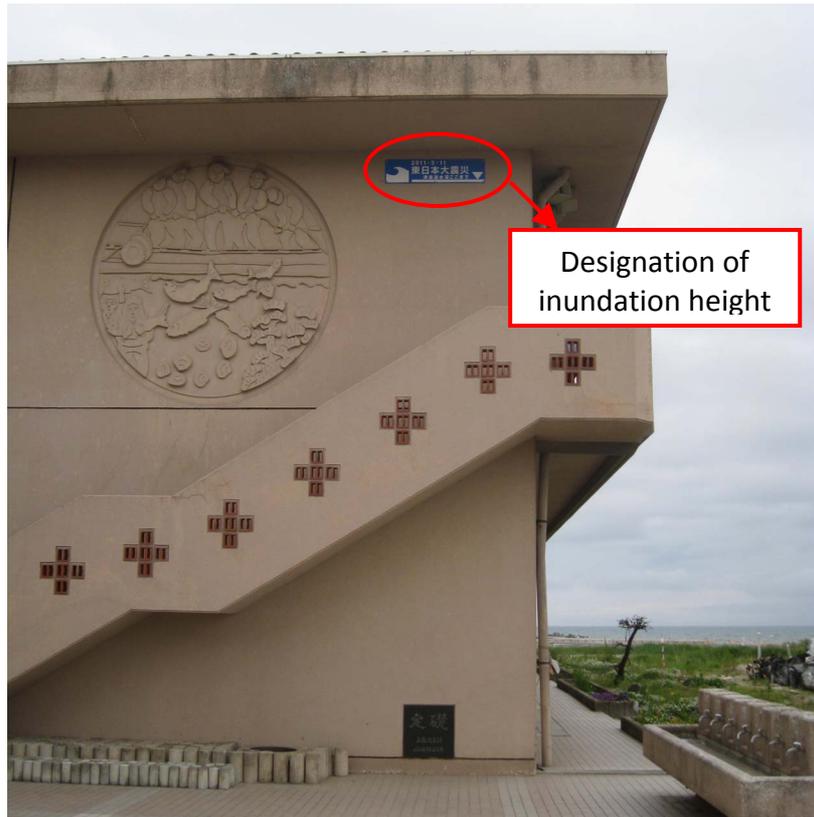
Yamamoto is a coastal town at the southern border of Miyagi prefecture, which was likewise heavily damaged by the tsunami. The team visited a still standing elementary school outside the town, and about 500 m from the waterfront. Apart from the school building, there was also a gymnasium that was partly sheltered by the school. The school building was well aligned to minimize tsunami forces, although it is not known if this was a design requirement or a random choice. The interior of the building was completely inundated, though the school was featured in the media for the successful vertical evacuation of all students on March 11, 2011. The recorded inundation height in that area was about 6m. From the first floor of the building the sea dike at the waterfront could be seen. The structure breached in several points and large armour units scattered on its inland side could be seen.

Figure 3.25: Designation of inundation height on the school building photographed in June 2012.

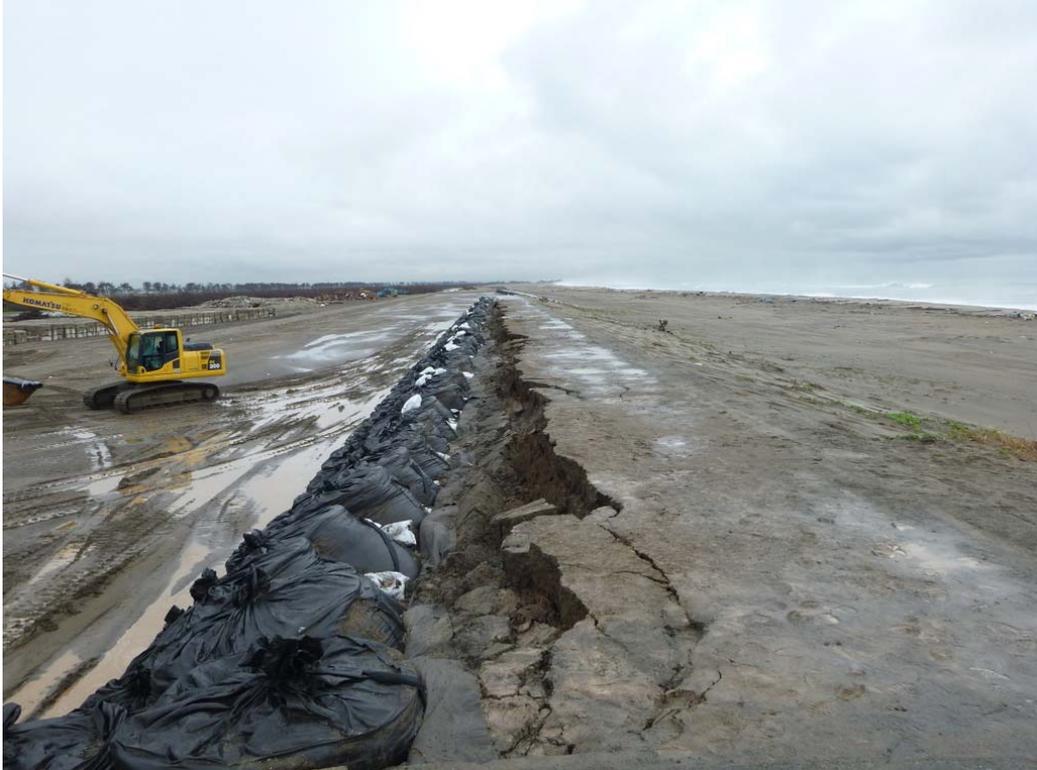
was being urgently repaired the day of the visit. This clearly showed the necessity of temporary interventions in order to keep the inner land protected.

Figure 3.28: Crest of coastal dike one day after the pass of typhoon Roke, 22 September 2011 (Source: Disaster Prevention Research Institute, Kyoto University; Courtesy of Tomohiro Yasuda, *all rights reserved*)

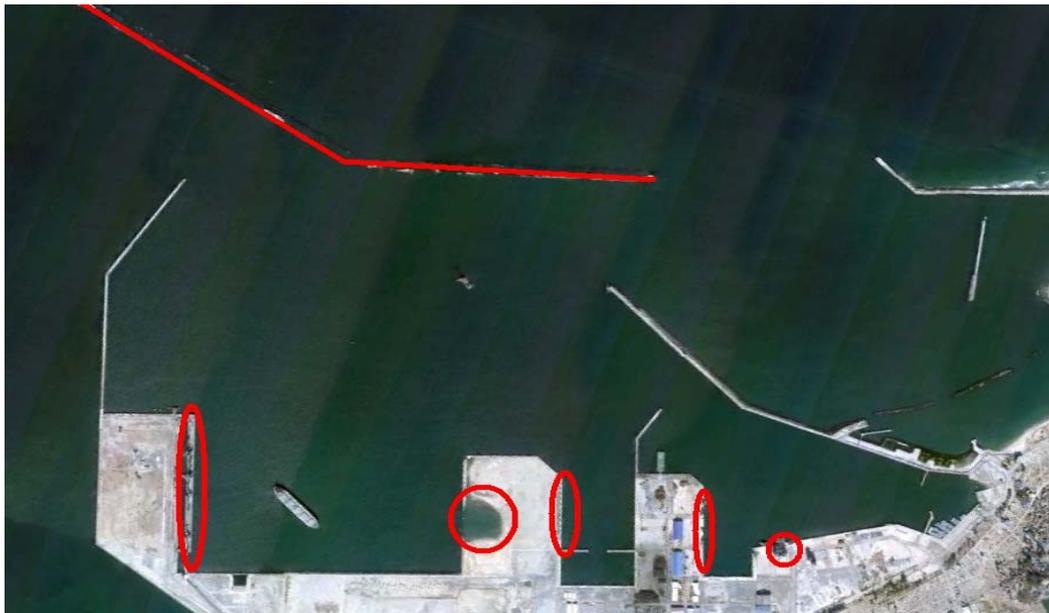
Figure 3.29: Port of Soma after the tsunami. The most severely damaged parts are indicated (Google Earth caption, 2011)

The port of Soma is an important commercial port on the coast of Fukushima, 32 km to the south of Sendai airport. As it is located on the straight coastline and not sheltered by natural barriers, it is protected against storm waves by a 2.6 km long offshore caisson breakwater, which was severely damaged by the tsunami of March 11. Only 3 out of the 546 caissons of the breakwater remained in place. The rest were displaced, and some could no longer be seen.

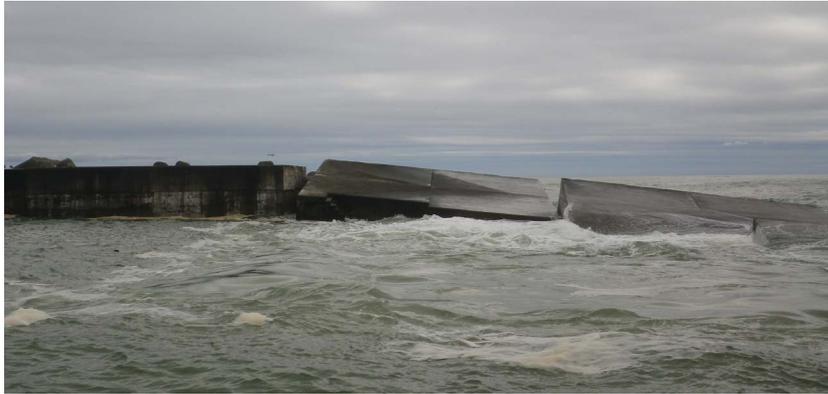
*Figure 3.30: Damage of the caisson breakwater (Source: DPRI Kyoto University; Courtesy of Yusuke Tanaka)*

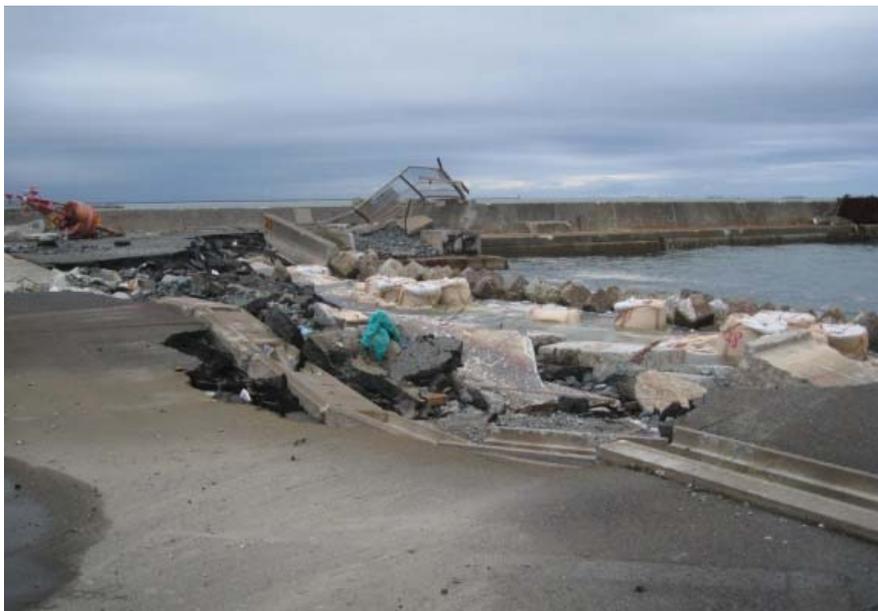
The rest of port infrastructures were likewise severely damaged. Some significant subsidence of the quay walls, exceeding 1 metre in places, was evident, and scouring at their foundation had taken place. It was notable that some concrete elements of the quay wall, with approximate dimensions  $6 \times 10 \times 3 \text{ m}^3$  were overturned and were left standing with their foundation upwards, which shows the enormous uplifting forces caused by the tsunami and that were intensified by the scouring. Furthermore some severe damage of warehouses and cranes could be observed. Inundation heights of up to 10 m were recorded in the port of Soma.

*Figure 3.31: Damage of quay wall. After the tsunami sandbags were placed to protect further erosion, which were removed during a typhoon attack a few hours before photographed.*

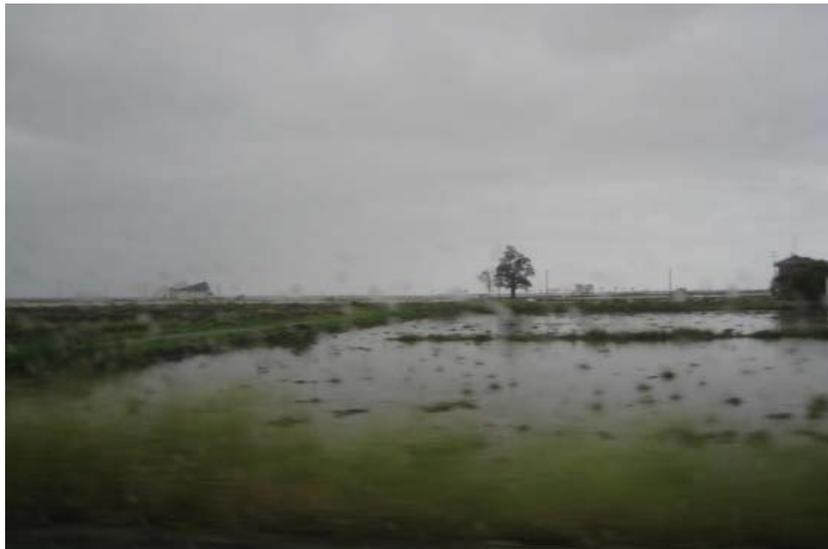
To the South of Soma port the city of Soma can be found, with a population of 38,000 inhabitants. Most of the city was located on higher grounds, and therefore it was not seriously affected by the tsunami. However an estuary with flat agricultural land in front of it subsided and was inundated by the tsunami. The bad weather conditions during the visit, together with the high water levels that had intruded the subsided land, did not allow access to many parts of this area. This was in fact the case in more areas in the coastal plain, which shows how vulnerable this land is after the tsunami.

*Figure 3.32: Inundated agricultural land on the waterfront of Soma*

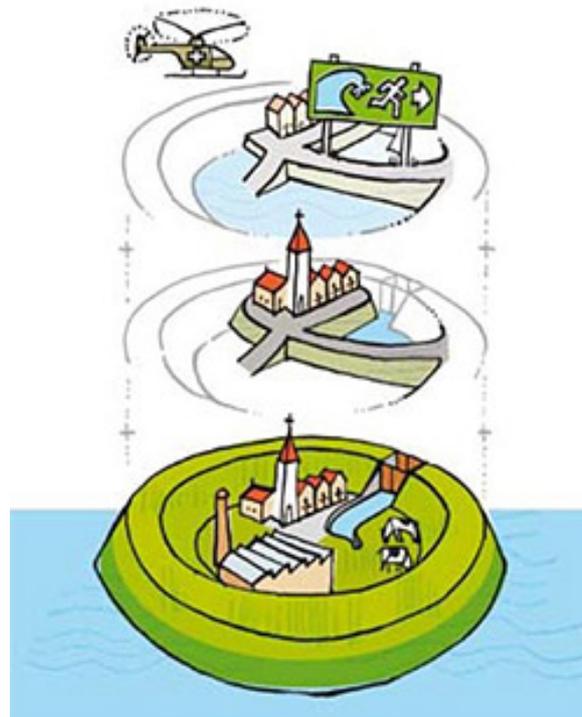
Figure 4.1: Graphical display of multiple layer safety (Source: Kolen et al. 2010)

Multi-layer safety is a concept in flood risk management that introduces the integration of flood risk probability-reducing measures and loss-mitigating measures in a flood protection system. Essentially the role of the former is to prevent inundation, while the latter are meant to function only in case that an extreme event exceeds the expectations of the prevention lines, and inundation occurs. This concept can be found in international literature with many different names, such as multi-level approach or multiple lines of defence. The term multi-layer safety has been mainly used in the Dutch flood risk management, and it also appears in the National Water Plan of the Netherlands as a national policy choice for safety against flooding. A graphical representation of multi-layer safety is shown in the figure below.
