# The Great Eastern Japan Earthquake and Tsunami

## Facts and implications for flood risk management

Edited by  
Vana Tsimopoulou

September 3, 2012

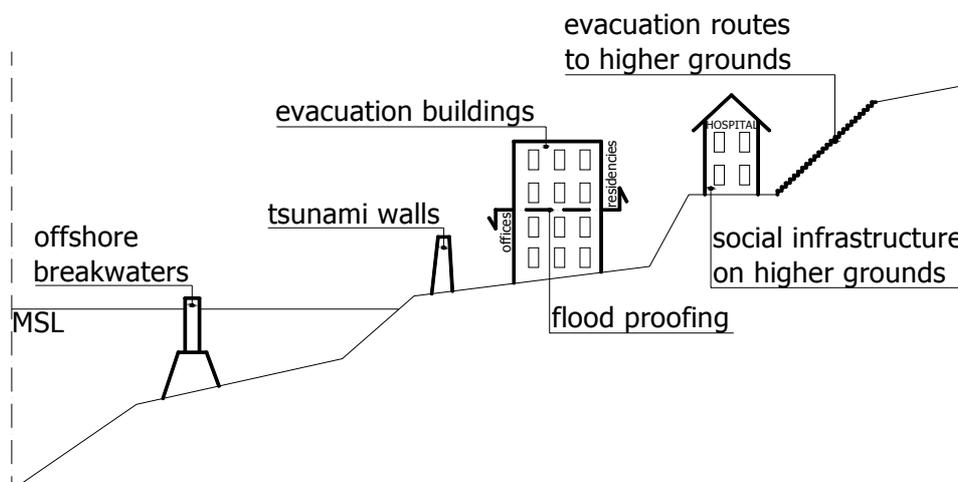
Figure 4.2: Tsunami countermeasures in the rias (MSL=mean sea level)

An overview of the tsunami countermeasures in the rias and in the coastal plain region is shown in the figures below. They are further described in the following paragraphs.

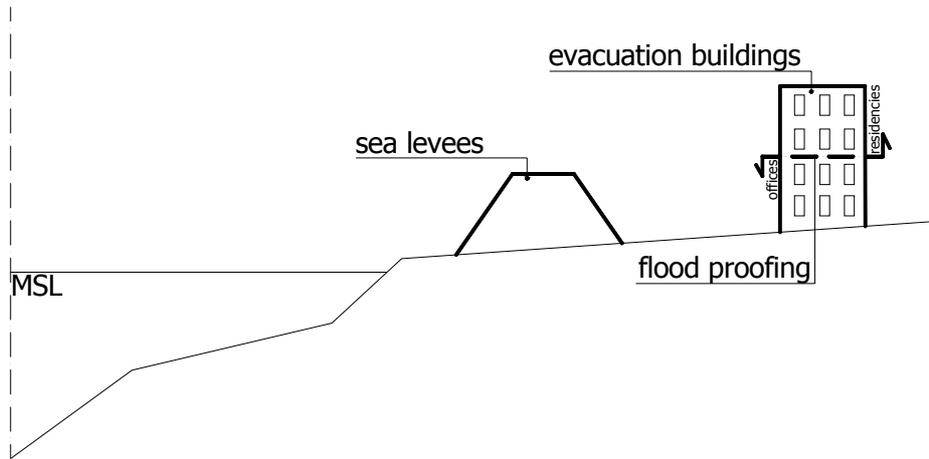
Figure 4.3: Flood risk countermeasures in flat plain region (MSL=mean sea level)

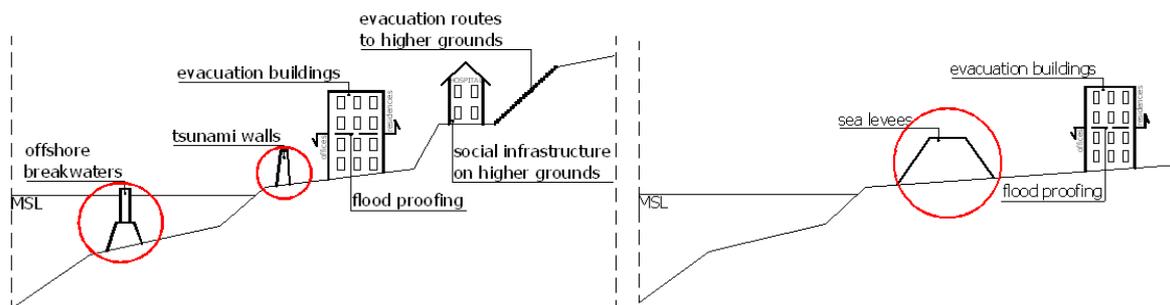
Figure 4.4: Layer 1 measures in the rias (left) and in the coastal plain (right)

The measures of layer 1 encountered in Tohoku were structures of different types along the rias of Sanriku region and along the flat plain coasts of Sendai region. The primary defences along the rias consisted mainly of offshore breakwaters and tsunami walls, while along the flat plains coastal dikes on the sandy frontage were the most common defence (figure 4.4)

These structures suffered severe damages with some of them failing catastrophically (ref. Chapter 3). Based on this fact, it becomes clear that their design specifications were exceeded by the tsunami of March 11, 2011. It is also notable that although all of them were located on a tsunami-prone coast, there was no consistency in their design specifications. Some of them were designed to withstand tsunamis, such as the offshore breakwater of Ofunato in the rias, while others were designed against storm waves, such as the breakwater of Onagawa in the rias and most of the coastal dikes in Sendai area. These variations could be justified by a general tendency in the Japanese flood risk management to design new defences based on previous experience with extreme events. In particular, the crest height of coastal defences in Japan is normally determined by the most severe condition between 1) previously experienced tsunamis, and 2) a 50-year-return wave on a storm surge. The difference between the time when each of the structures was constructed and the available amount of knowledge at the time in terms of recorded extreme storms and tsunamis can explain the inconsistency in design specifications. Some structures were much younger than others and probably designed to resist higher loads.

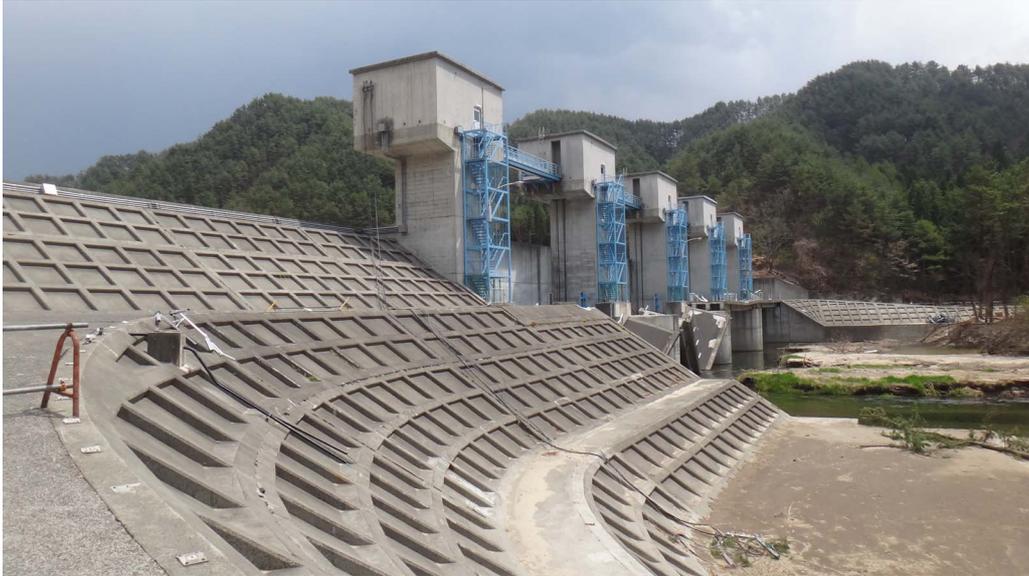
Figure 4.5: Tsunami wall in Fudai (Source: Tokyo University of Marine Science and Technology; courtesy of Akio Okayasu; all rights reserved)

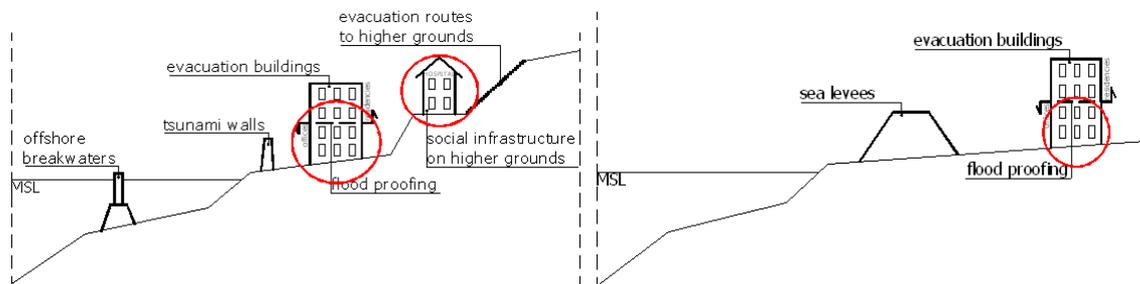
Figure 4.6: Layer 2 measures in the rias (left) and in the coastal plain (right)

The spatial arrangements that seem to be part of layer 2 measures are the placement of important social infrastructure buildings to higher grounds, and the flood proofing of high buildings by accommodating the most important functions in higher floors (figure 4.6).

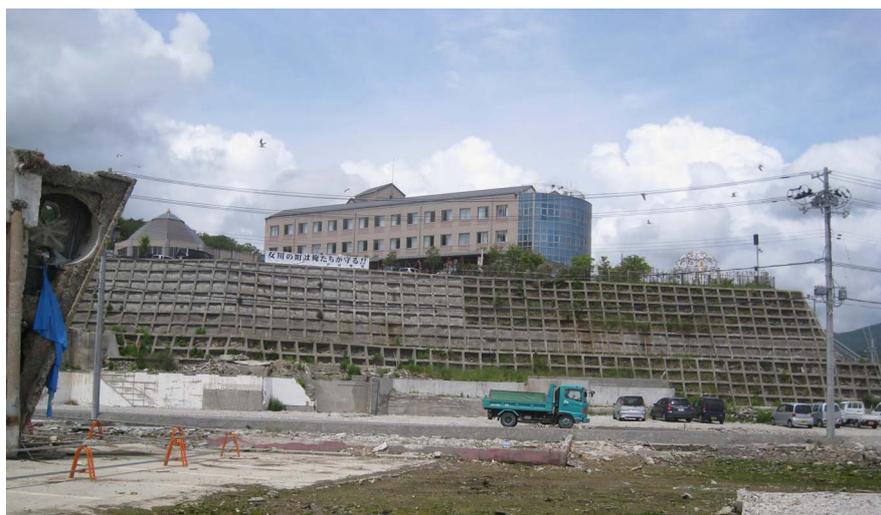
Figure 4.7: Hospital of Onagawa

Concerning the allocation of community functions to higher grounds, it should be noted that not all essential functions stayed unaffected. There were schools and hospitals located on grounds that were high enough to remain either completely or relatively less affected than the majority of buildings. Such is the case of the junior high school of Shizugawa on the northwest of Minamisanriku, situated 47 m above sea level. Another case is that of the hospital of Onagawa, on a ground elevation of 15 m, where only the ground floor was inundated. The location of those buildings may have been decided taking into account the risk of a tsunami.

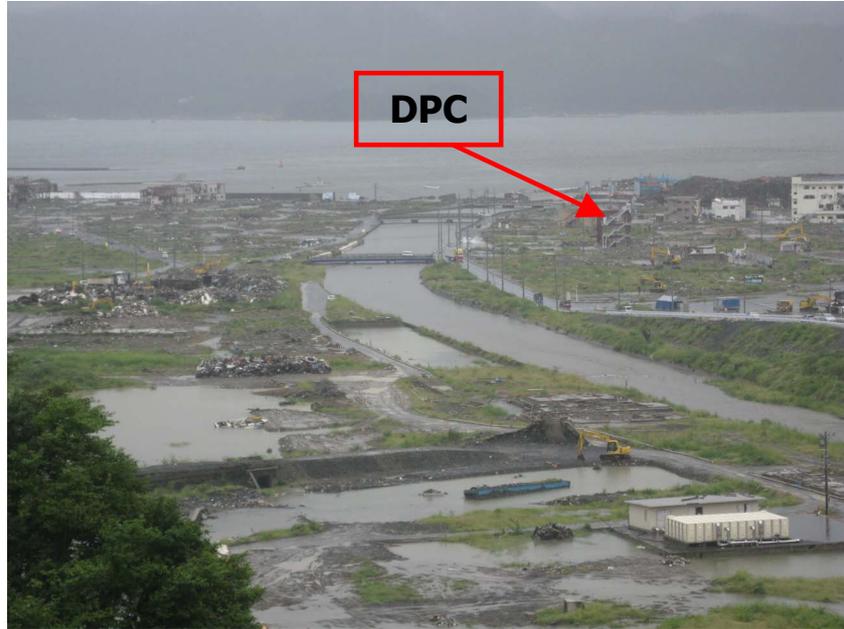
*Figure 4.8: Location of the Disaster Prevention Centre of Minamisanriku*

smaller tsunami had taken place. The Disaster Prevention Centre of Minamisanriku was placed very close to the waterfront, and it was devastated (figure 4.8). It is therefore not clear if the use of spatial planning for the enhancement of flood protection was part of a firm strategy.

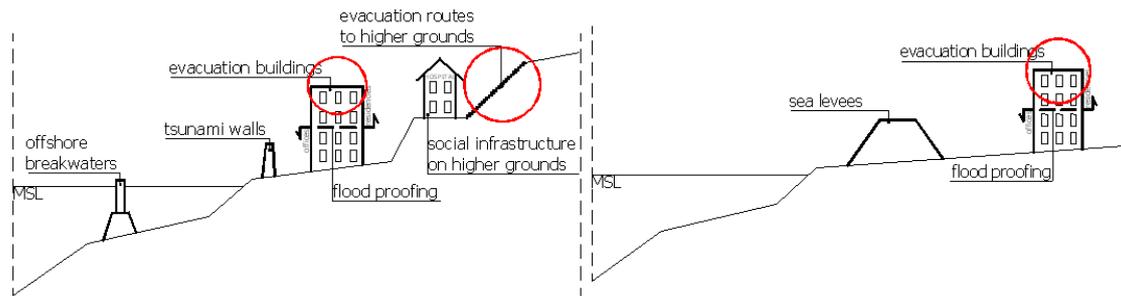
Concerning evacuation, slightly different schemes were followed in the rias and in the plain region. In the rias, due to the existence of high mountains adjacent to the coast, evacuation to higher grounds was the main strategy, while there were also some evacuation buildings. In the plain region evacuation buildings could be found in urban areas, while evacuation to higher grounds was in most of the cases only possible by car.

Figure 4.9: Evacuation measures in the rias (left) and in the plain region (right)

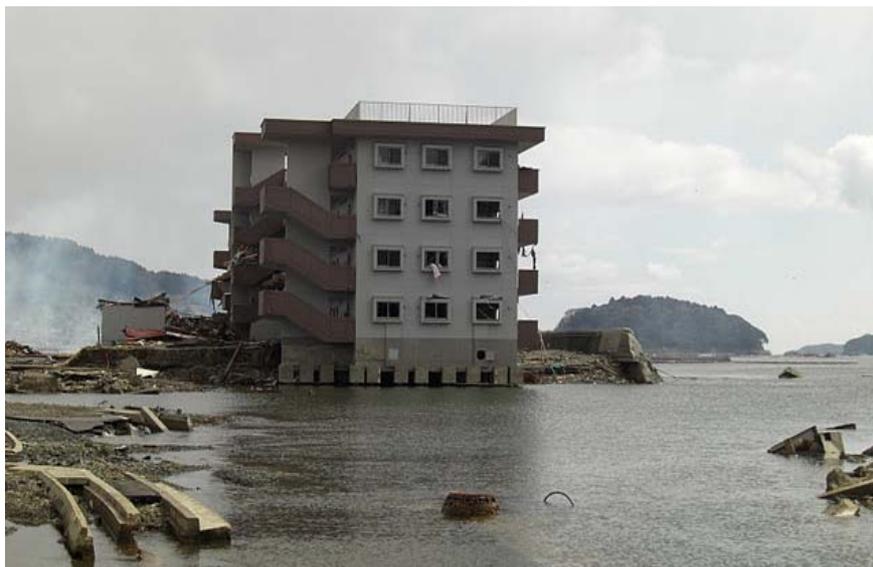
Figure 4.10: Evacuation building on the frontage that was just overtopped, people sheltered on the top of it survived (Source: The 2011 Tohoku Earthquake Tsunami Joint Survey Group; [www.coastal.jp/tsunami2011](http://www.coastal.jp/tsunami2011))

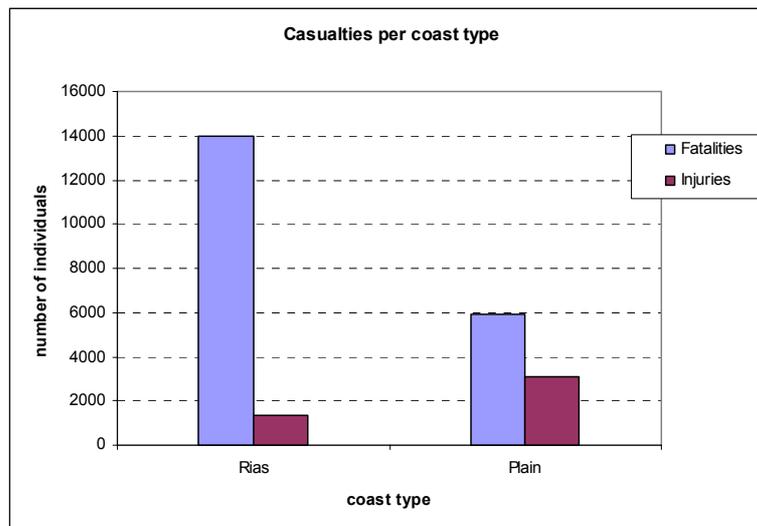
The following graph, which is based on the same records, shows that fatalities in the rias outnumber fatalities in the plain region, while the rate of injuries over fatalities is lower.

Figure 4.11: Recorded casualties in the rias and in the plain region (Data Source: Kyoto University, November 2011)

The inundation of evacuation centres can be one of the reasons for the much higher fatalities recorded in the rias. The higher rate of injuries over fatalities in the plain implies that most people exposed to the tsunami flow in the rias died, while in the plain many of them survived.

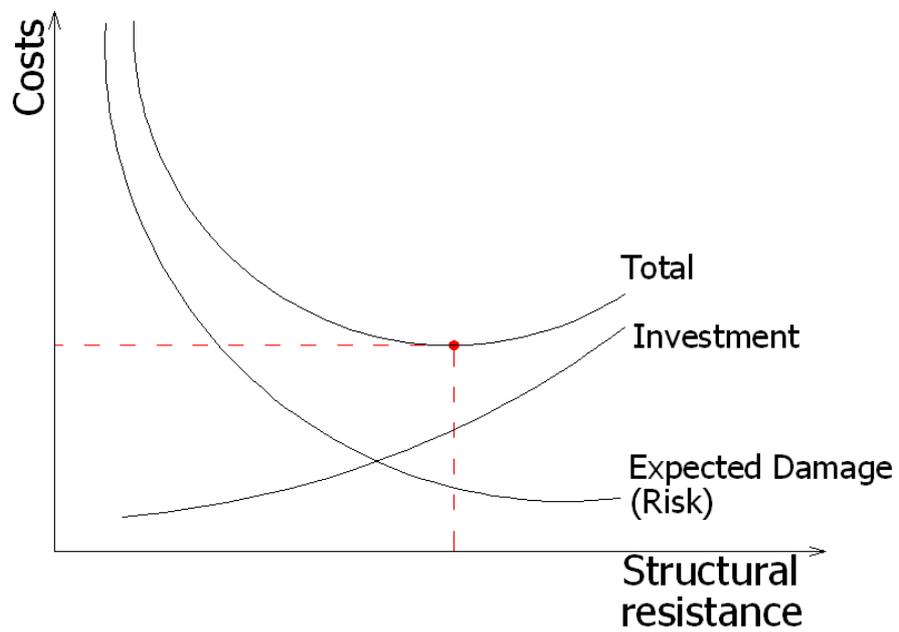
In order to have this condition fulfilled, a common reference point for the evaluation and comparison of different measures and safety layers is necessary, which can only be the degree of safety that each measure adds to the system. This requires a risk-based approach to flood protection to be pursued (Tsimopoulou et al. 2012). In this case the target reliability of every measure under consideration should be the outcome of a cost optimization that takes into account risk in an explicit way. In particular the risk reduction offered in the system by the new measure is considered as economic benefit in this type of optimization, and the total cost function is presented in figure 4.12. As optimal investment the one that minimizes the cost function is considered.

Figure 4.12: Total cost function for cost optimization of flood defences

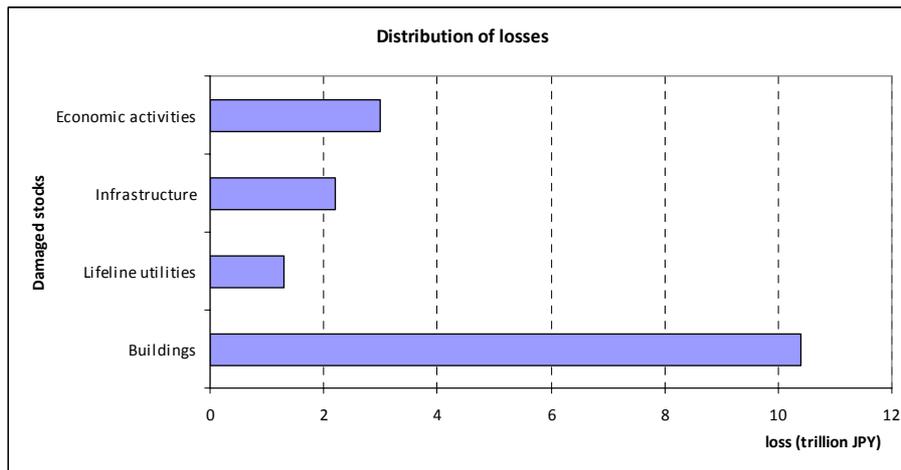
The distribution of losses in stocks as estimated in February 2012 is shown in the figure below.

Figure 5.1: Distribution of losses over stocks (Government of Japan, 2012)

The above graph refers only to tangible stocks. Intangible losses such as fatalities, cultural and environmental degradation, and psychological effects on the victims cannot be easily expressed in monetary value. Yet mortality rates and the relative degree of damage over the exposed area or stocks can be computed, and are fairly good indicators not only of the total losses, but also of the performance of the tsunami protection systems in Tohoku. As mentioned in chapter 4, a complete assessment of the performance of the system of Tohoku requires the elaboration of site-specific analyses, including analysis of fatalities and the degree of damages, which can be later compared to the physical characteristics of the tsunami inundation. Hence many studies have been being carried out since completion of damage and casualties records, some indicative results of which are summarized in the figures below.

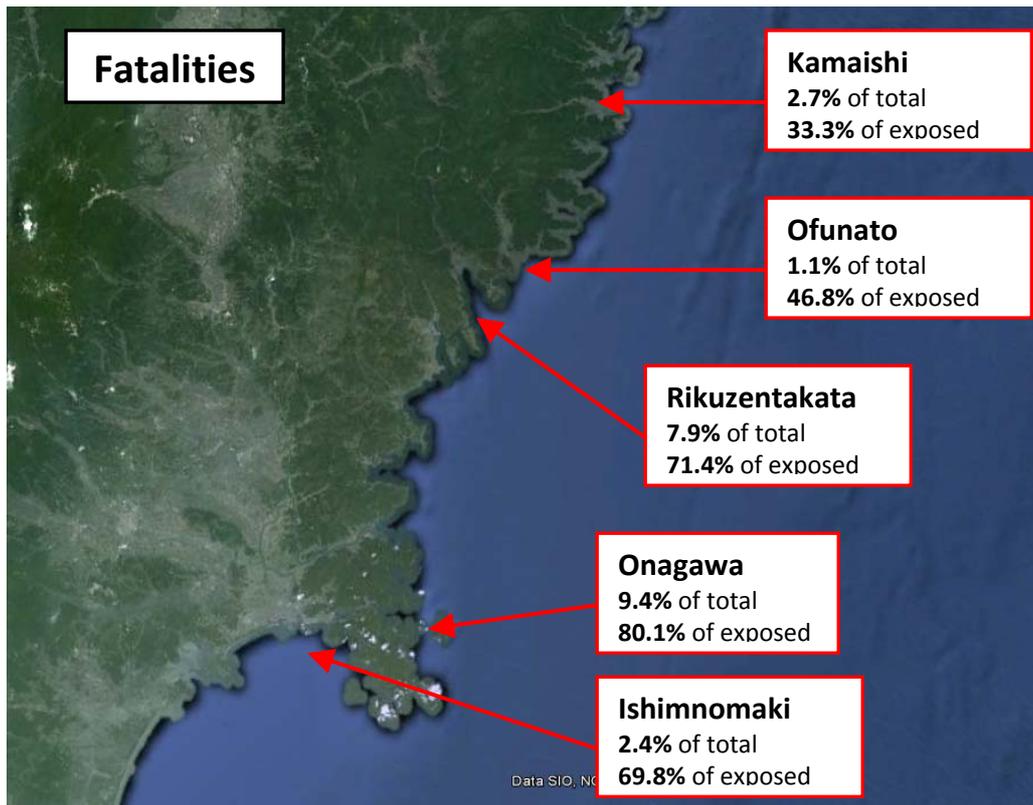
Figure 5.2: Percentage of fatalities over total and exposed population in five affected urban areas in the rias (Data source: Oyama 2012)

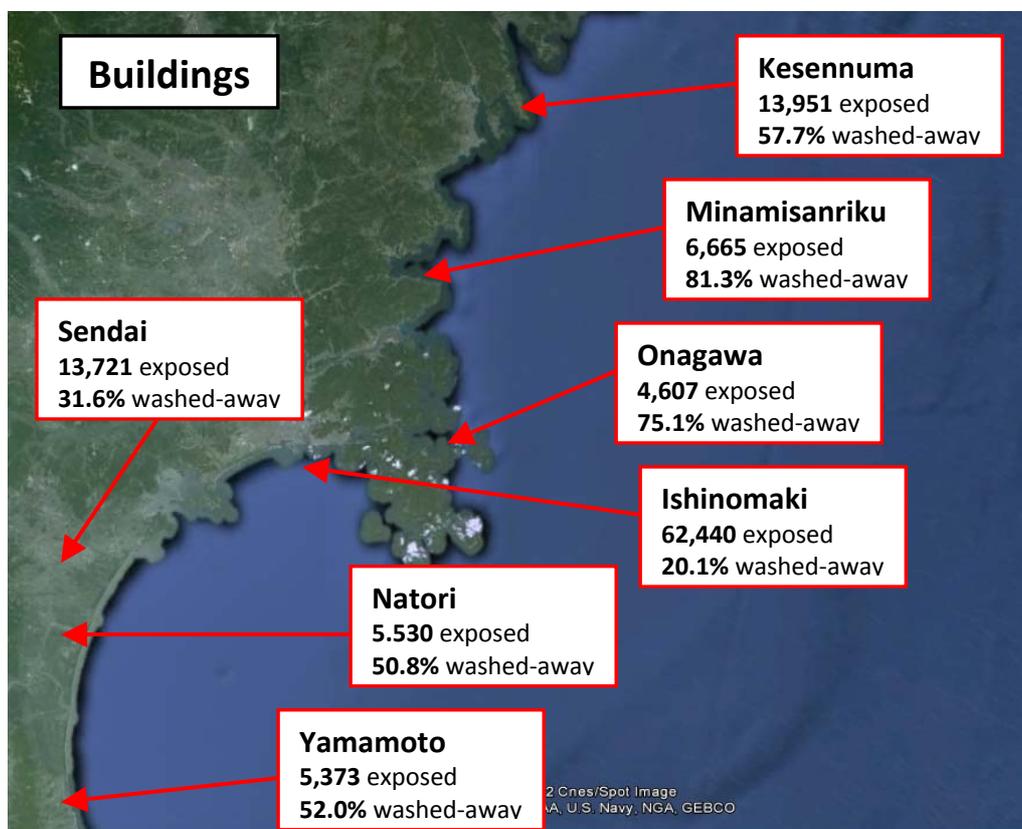
Figure 5.3: Percentage of washed-away buildings over exposed, and total number of exposed buildings in various urban areas (Data source: Gokon & Koshimura 2012)

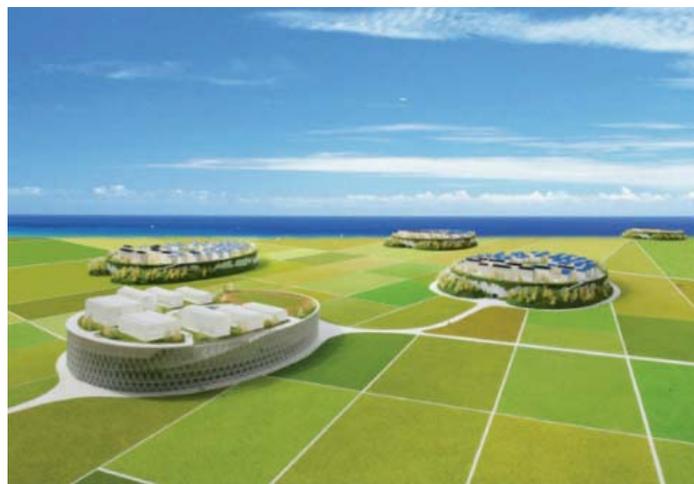
An interesting damage mitigating design has been suggested by Keiichiro Sako, a Japanese architect, the so-called sky villages. The design concerns the new spatial development of the devastated villages in the coastal plain of Sendai region on artificial high grounds.

Figure 5.5: Design for sky villages in Sendai coastal plain (Source: Designboom; <http://www.designboom.com>; all rights reserved)

Although promoting the coexistence of social-economic and natural environment, the cost efficiency of such sky villages should be thoughtfully considered. A sky village needs an expensive initial cost to construct the mounds, houses, and infrastructure, and a low cost to maintain the infrastructures that are concentrated in the village. The Japanese population has already reached its maximal and will decrease because of a small birth rate. Many infrastructures, which were constructed during the Japanese post-war economic miracle decades, late 1950s-first 1970s, are now approaching the repair or reconstruction time. From these viewpoints, a highly dense compact village may be within a range of the discussion.

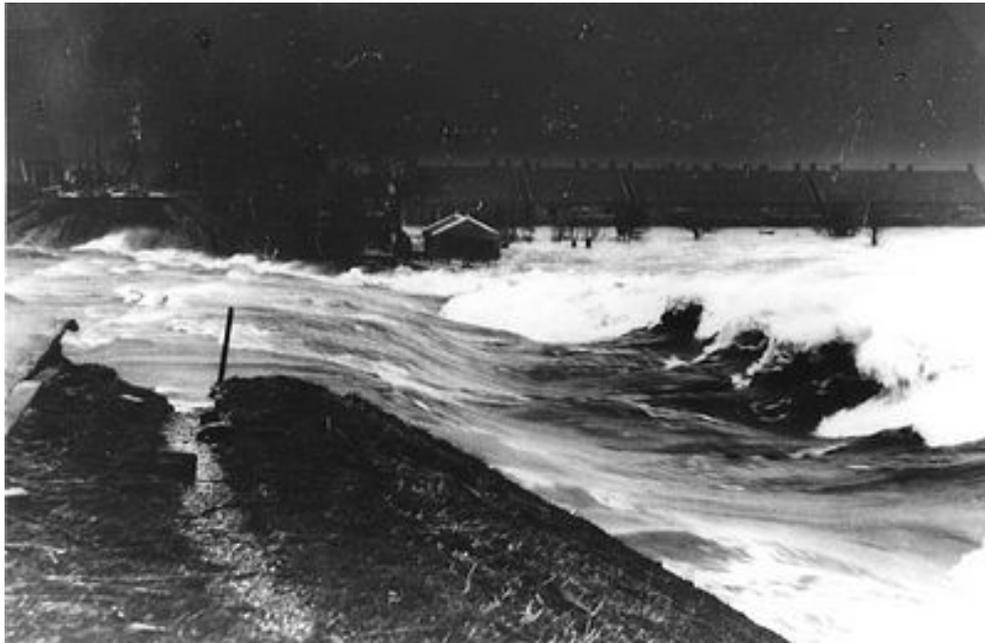
In February 1, 1953 one of the biggest floods ever recorded in the Netherlands occurred. The night of January 31 a severe storm in the North Sea induced very high water levels along the Dutch flood defences in the southwest of the country. The storm lasted several hours. The high water levels that were periodically intensified by the spring tide exceeded the capacity of the flood defences. As a consequence many dikes failed. In total 89 dike sections collapsed, and breakages and damages could be found over a length of 187 km. That night about 1800 people were drowned and thousands were evacuated. The economic damage was also serious.

Figure 6.1: Dike breakages in the Netherlands, 1953 (Source: [www.deltawerken.com](http://www.deltawerken.com))

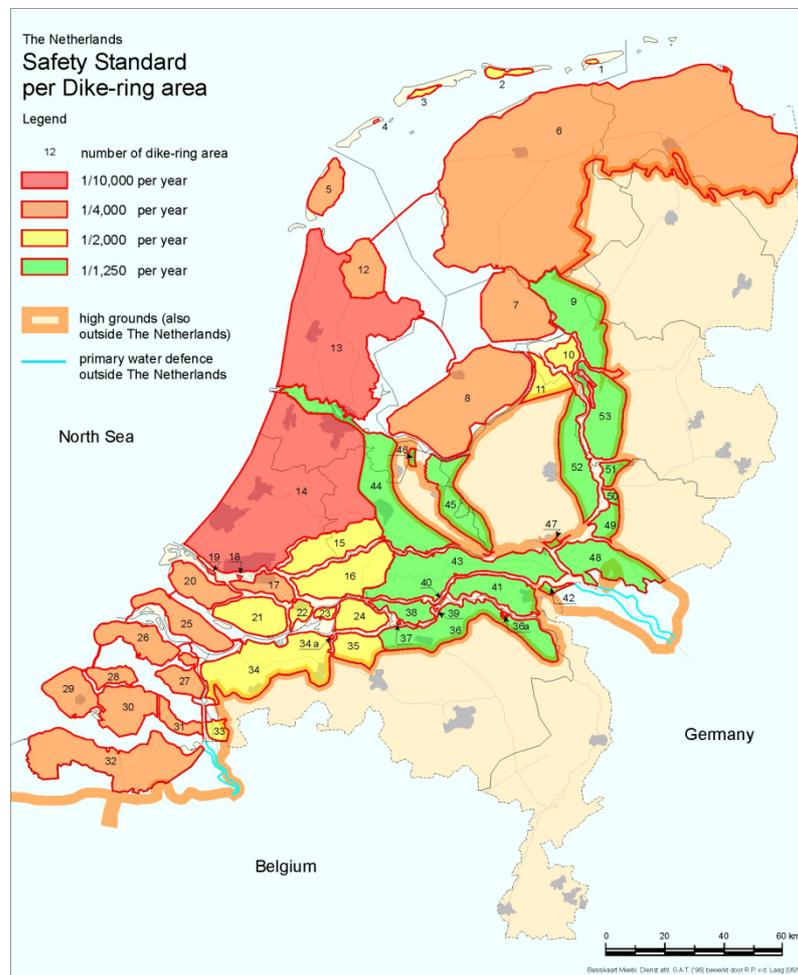
The recommendation of the Delta Commission started being implemented immediately with the construction of the Delta Works in the period 1958-1997. The safety standards were legally mandated within the Act of flood defences in 1996. The map indicating the safety standards of the Dutch dike rings can be seen below (figure 6.2). The safety of the dike rings as well as the safety standards are currently reassessed in a regular basis.

Figure 6.2: Safety standards in the Netherlands, 1996

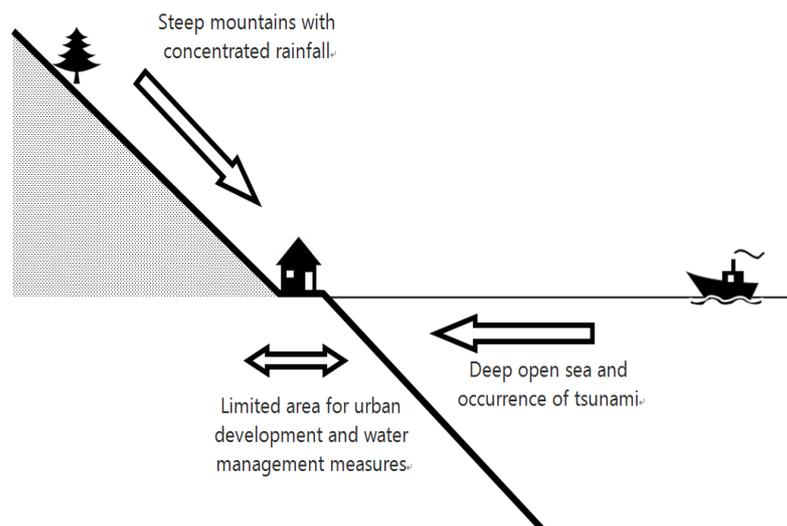
Urban development over the past half century in Japan has had a large impact on the water management system. Waterways had already lost much of their transport function since the introduction of railways at the end of the 19<sup>th</sup> century, and roads in the 20<sup>th</sup> century. But economic growth and strongly increasing land prices reduced space for waterways in urban areas to a minimum. In terms of water management this was not always an optimal situation, as most of these areas are situated along the coast and in between steep mountains and ocean areas characterised by their steep seabed.

Figure 6.3: Characteristics of the Japanese coastal zone

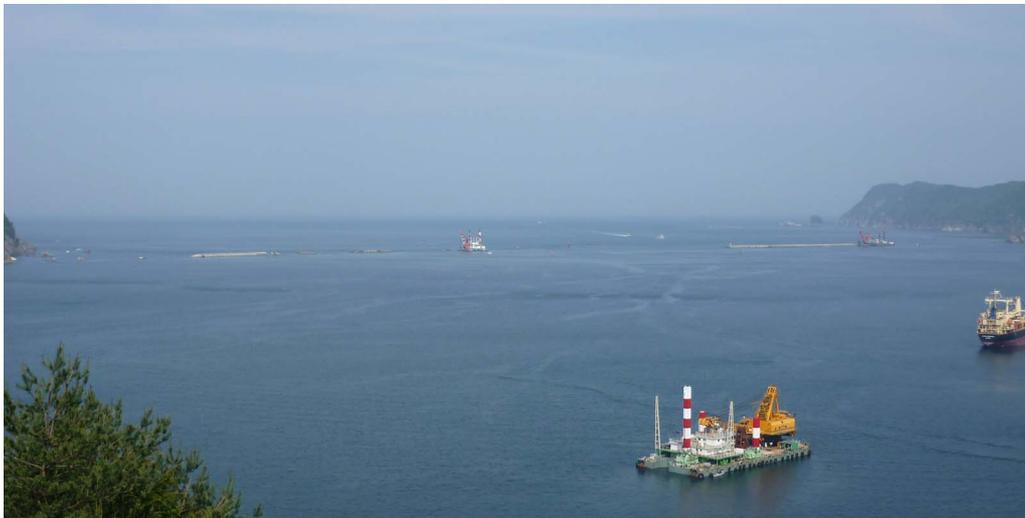
Figure 6.4: World's deepest breakwater in Kamaishi, photographed in June 2012, during its reparation
