A pragmatic, performance-based approach to levee safety assessments

Flood prone areas are often protected against flooding by an extensive network of flood defenses. To ensure their structural integrity, these flood defenses are periodically assessed. Many levees have been functioning well for decades, and have survived several relatively high hydraulic loads within their lifetime. However, information on survived load conditions is seldom included in levee safety assessments. Observed degradation from levee inspections is also not taken into account. That way, information that is useful to improve the accuracy of estimations of the actual strength of the levee remains unexploited. This study proposes a pragmatic approach to include observations of survived loads and levee degradation in the levee safety assessment. This approach consists of three steps: (1) a prior estimation of the failure probability, based on levee characteristics, (2) a posterior estimation of the failure probability, based on observed hydraulic loads, and (3) correction of the posterior failure probability estimation, based on levee inspections. In a case study, the estimated failure probabilities using this

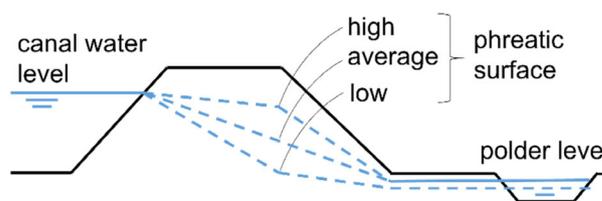
FIGURE 1 Schematic representation of possible phreatic surface levels (high, average, and low)

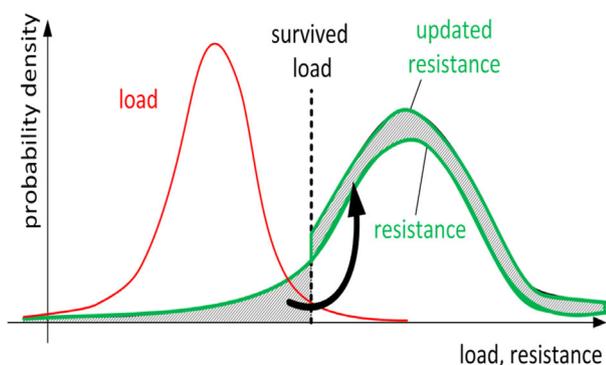
In which $P(F|\epsilon)$ is the probability of failure, given observation ϵ . This is illustrated in Figure 2: the failure probability is determined by the probability density of the load (in red) and the probability density of the resistance (in green). When the levee resistance is constant in time, a survived load (at dashed vertical black line) serves as evidence that the probability of failure for that load (and smaller loads) equals zero. The probability density under that load is then redistributed over the probability density above that survived load, reducing the levee’s overall failure probability.

FIGURE 2 The concept of “reliability updating,” where the probability density under the survived load is redistributed over the probability density above the survived load (Schweckendiek, 2014)

conditional probability of failure from Equation (2), by defining a new limit state of the intersection (cut set) of failure and the observation ($F \cap \epsilon$), as described by Schweckendiek et al. (2016). The correlation between the survived load and the current (or future) situation was assumed equal to one: the strength does not change. In other words, there have been no changes in the levee that might have led to an increase or decrease of its strength properties. This leads to an adjusted probability density of the estimated levee’s resistance. Figure 2 shows how the probability density function of the resistance is redistributed following a truncated normal distribution (Schweckendiek, 2014). The figure shows there is no probability density left below the observed water level.

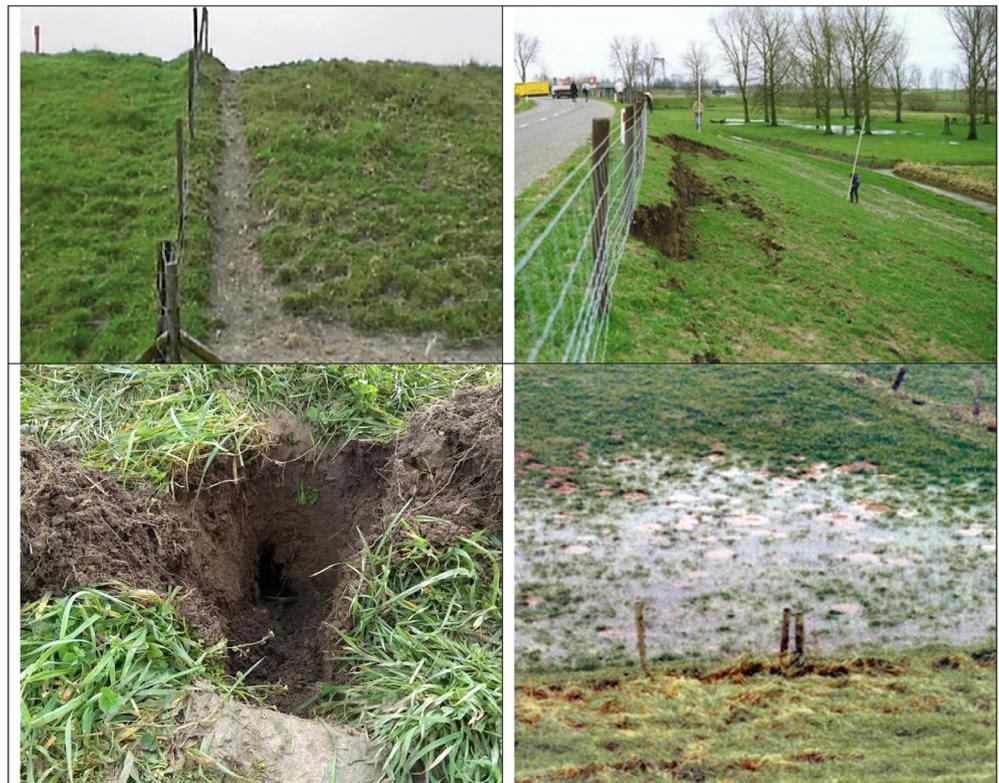
FIGURE 3 Examples of performance indicators. Local subsidence due to trampling by livestock (upper left; picture from STOWA, 2018), severe subsidence (upper right; picture from STOWA, 2018), animal burrowing (lower left, picture taken by S.J.H.Rikkert, 2020), and wet spots at the levee toe (lower right; picture from STOWA, 2018)

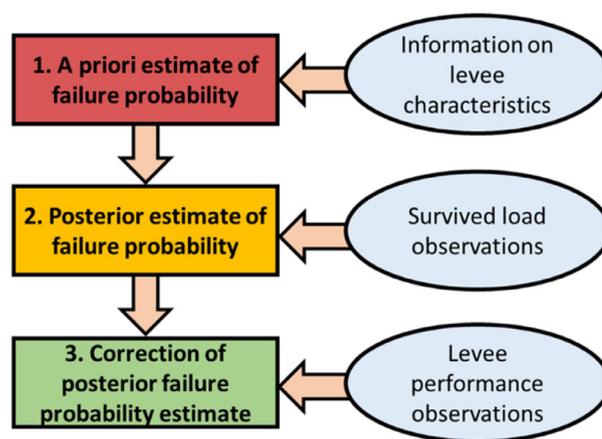
Figure 4 shows a schematization of the proposed approach. The first step of this method is to estimate the failure probability, based on levee specific load and strength parameters. In the two following steps, this estimation is improved by including observed levee behavior.

FIGURE 4 Schematization of the proposed method to estimate the failure probability, utilizing information on levee performance under critical conditions and levee inspection results

1. The first step is to determine the a priori annual failure probability (P_f). Probabilistic stability calculations are performed for each levee section, providing both the safety factor SF and the reliability index β . This can be done with a slope stability model. Levees with comparable characteristics, such as inner slope, soil structure and geotechnical parameters, can be

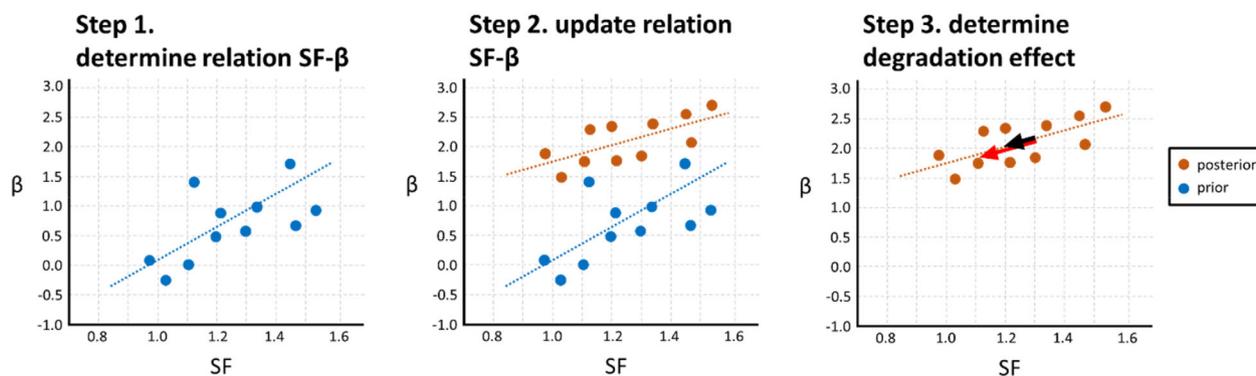
FIGURE 5 The approach explained through three steps. Step 1: Relation between safety factor SF and reliability index β for one levee type, based on probabilistic stability assessments. Step 2: Updating the prior relation between safety factor SF and reliability index β for one levee type, based on observations of survived hydraulic loads, with the prior relation in blue and the relation after updating in orange. Step 3: The arrows indicates how different degrees of degradation (black: light degradation; red: severe degradation) affect the stability factor, and hence the reliability index, of one levee type is influenced by levee degradation. The arrows are indicative, and effects on the stability factor depend on levee characteristics and degradation type

2. Observations of performance of the levee under various loading conditions can be included, using the approach described in Section 2.2.1 on reliability updating. The initial relation found in step 1 can be improved, by fitting a line through the points after reliability updating, as is shown in (see step 2 in Figure 5).

3. The final step is to correct the posterior failure probability by including results of levee inspections in the form of levee performance indicators, in addition to the survived loads from the previous step. These levee performance indicators contain information about the actual condition of the levee, and they influence the stability factor, and hence the probability of failure. Ideally, the same approach as in step 2 would be used here: including the effects of a certain performance observation, based on Bayes theorem. However, in this study a more pragmatic approach was used to limit the processing time of the study. Besides, discretization of the load and resistance in reliability updating makes it difficult to take into account gradual degradation. Therefore, we assumed that the effect of an observation (e.g., animal burrows) on the stability factor can be expressed as a reduction factor that is dependent of the levee type, the performance indicator and the level of severeness (see step 3 in Figure 5).

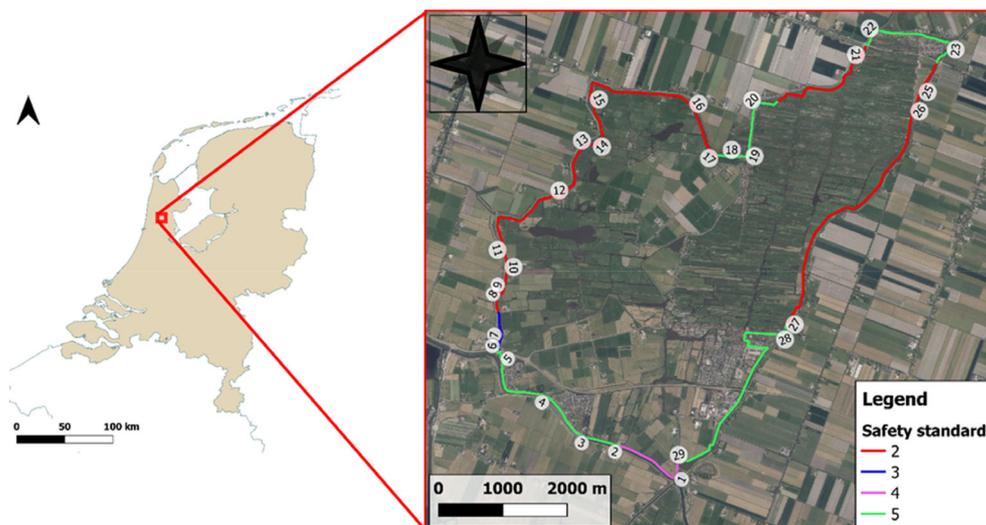
FIGURE 6 Left: Map of the Netherlands, with the location of the Eilandspolder. Right: Overview of levees protecting the Eilandspolder, the distinction into separate, numbered, levee sections, and their assigned flood protection standard

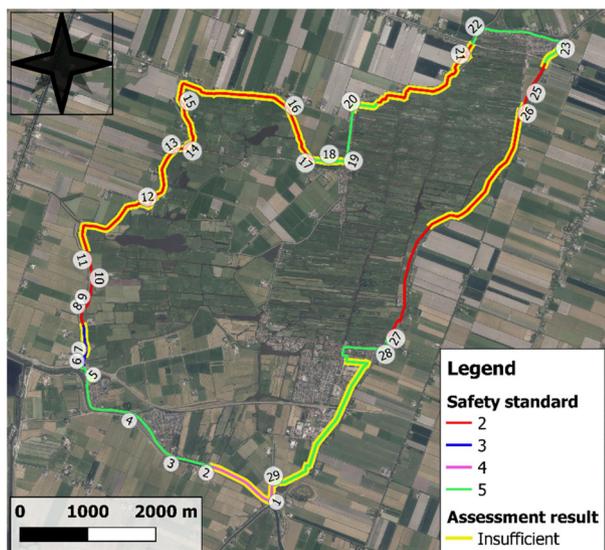
FIGURE 7 Overview of levees that do not meet the required safety standard for the failure mechanism macro-instability

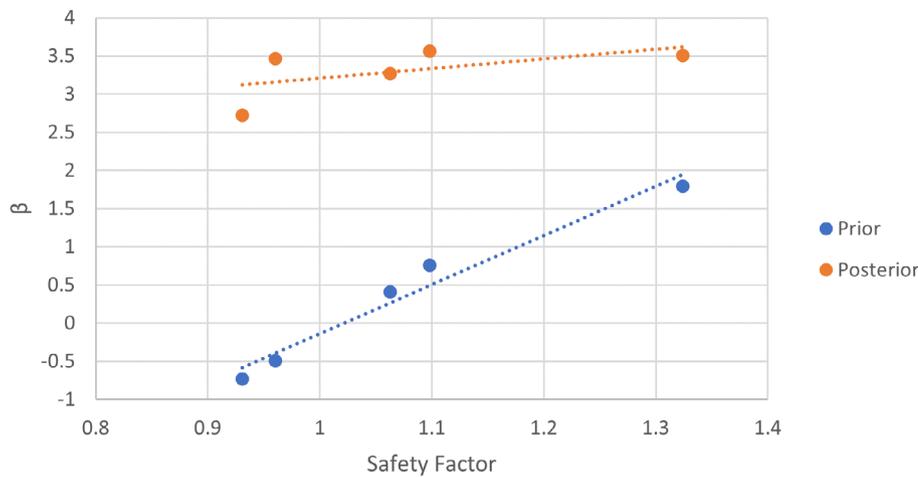
FIGURE 8 Results of probabilistic stability assessment for a-priori (blue) calculations and after reliability updating (orange)

Figure 8 shows the results of the stability analysis before and after reliability updating. As the figure shows, including observations of survived loads result significantly increase the estimated reliability index. The new Safety Factor and reliability index were found by assuming a failure probability of 0 during the survived load combinations.

The relation between β and SF after reliability updating shows a different, milder, slope than before updating, as can be seen in Figure 8. A possible explanation for this change in slope is that reliability updating might have a larger effect on stability assessments that resulted in low safety factors (low values for β), than on high safety factors, especially if the lower safety factors are caused by high uncertainties. Observations of survived loads will then result in a large uncertainty decrease and, consecutively, in higher reliability indices. If uncertainties are smaller, reliability updating is expected to have a smaller effect, resulting in a decreased slope.

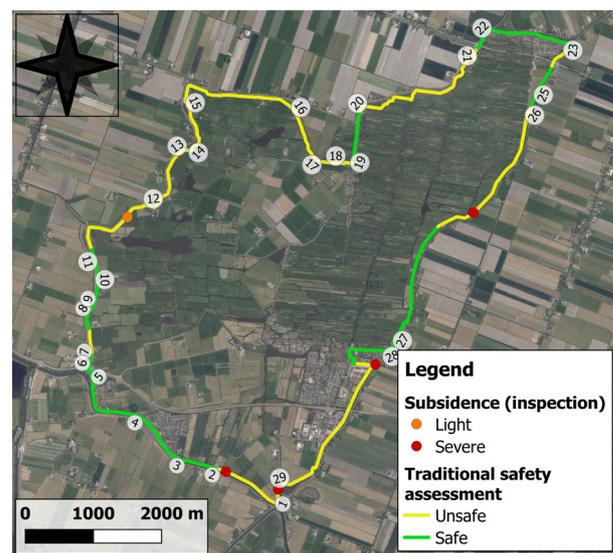
Figure 9 shows the severity of levee subsidence per location, observed during levee inspections over a course of about 2 years (2016–2018). The figure only includes observations of levees that were unsafe according to the semi-probabilistic safety assessment. A distinction is made based on the degree of severity of subsidence:

FIGURE 9 Map showing the subsidence observations from the levee inspection. Light subsidence is observed in section 4.5, and severe subsidence is observed in section 1 (on 2 locations), 8.2, and 9.2

- Light subsidence: about 0.25 m subsidence is observed in section 12;

- Severe subsidence: about 0.5 m subsidence is observed in section 1, 26, and 29.
